FULTON COUNTY  
DEPARTMENT OF  
PUBLIC WORKS

# Water Resources Management Program

## Volume 7 - Sandy Springs Study Area

June 2001

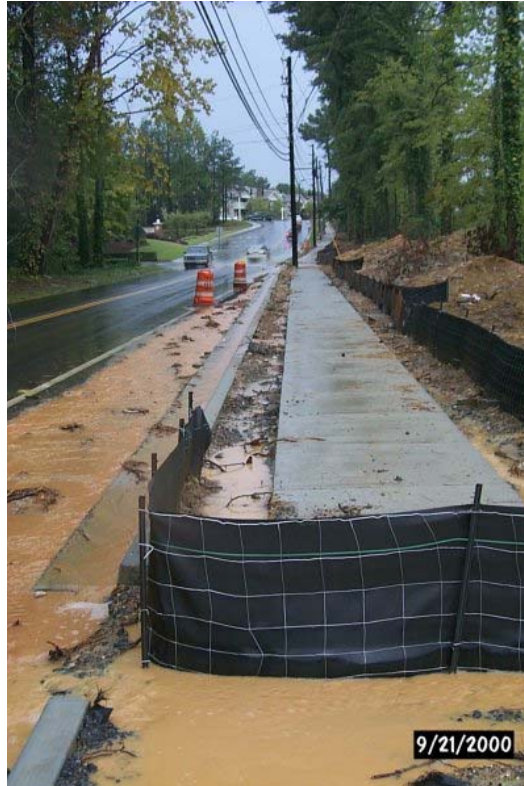
FIGURE 3-1  
Direct Runoff of Sediments at Construction Site

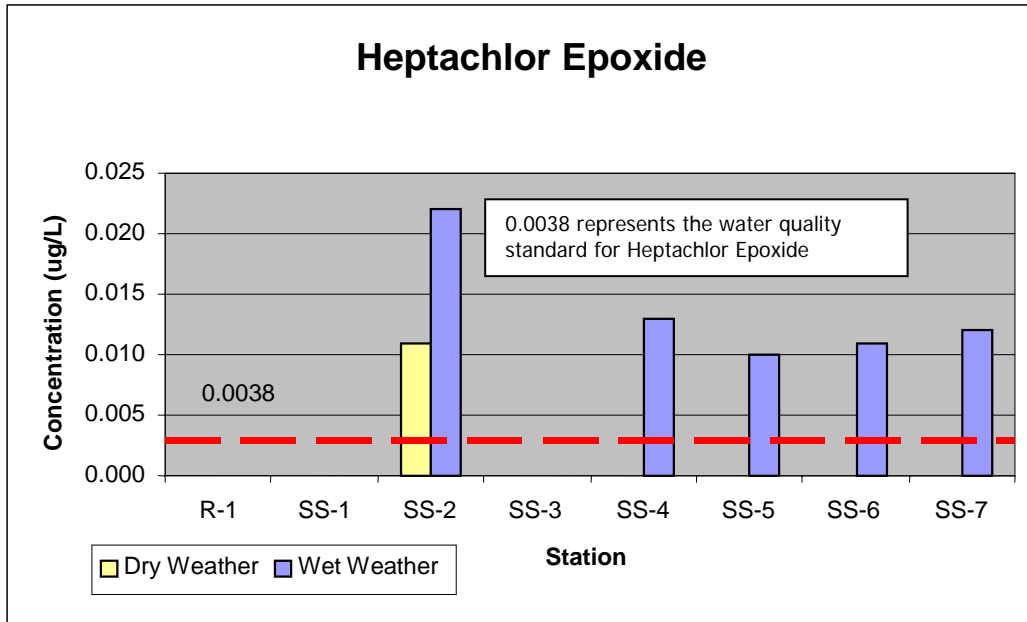
stormflow sampling. Since only one sample was collected across sites for each flow condition, these results may be an indication of a serious water quality problem and a potential human health risk.

FIGURE 3-12  
Heptachlor Epoxide Results for Single Dry Weather and Wet Weather Samples

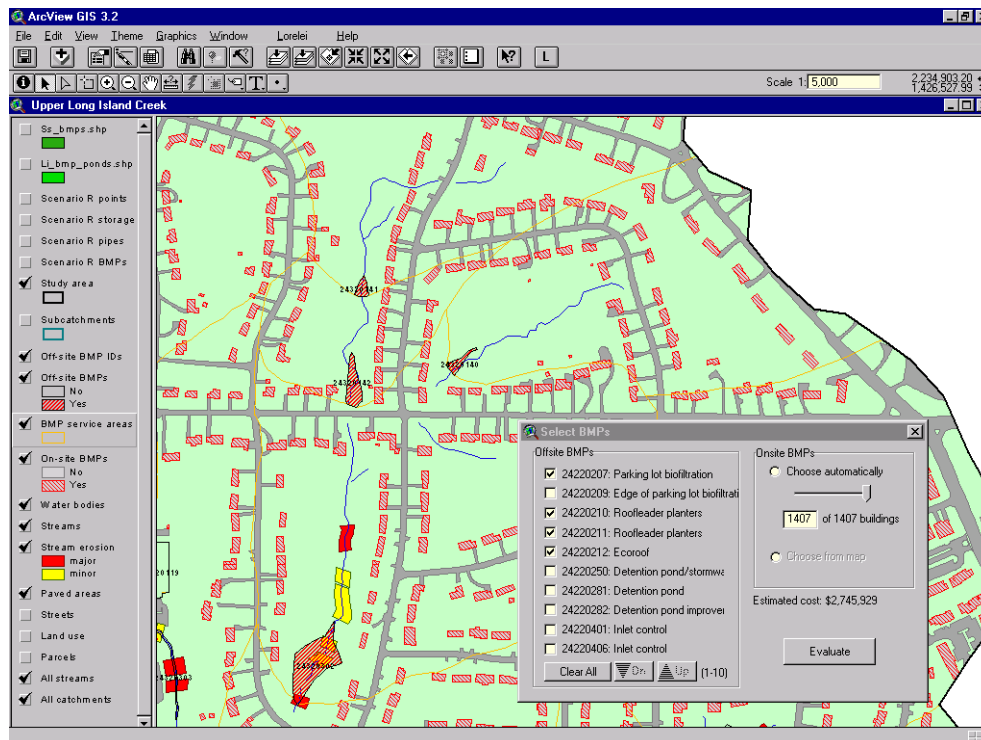
FIGURE K-3  
Masked Erosional Areas Underneath Pond 24320302 with Reduced Erosion Upstream due to Increased Storage
