City of Sandy Springs (COSS) completed a stream assessment inventory of the impaired streams watershed in COSS. COSS includes 32-miles of main stem and tributaries of impaired streams that confluence with the Chattahoochee River. These impaired streams are listed on the 2016 Georgia 305(b)/303(d) Report lists of impaired streams for *fecal coliform* bacteria (**Figure EX-1**). This listing is a result of elevated levels of bacteria and sediment which may be caused by the influence of urban stormwater runoff. The stream assessment inventory includes a review of the watershed, sanitary sewer inventory, stream assessment summary, potential best management practice (BMP), and recommendations for improving water quality.

City of Sandy Springs Stream Assessment

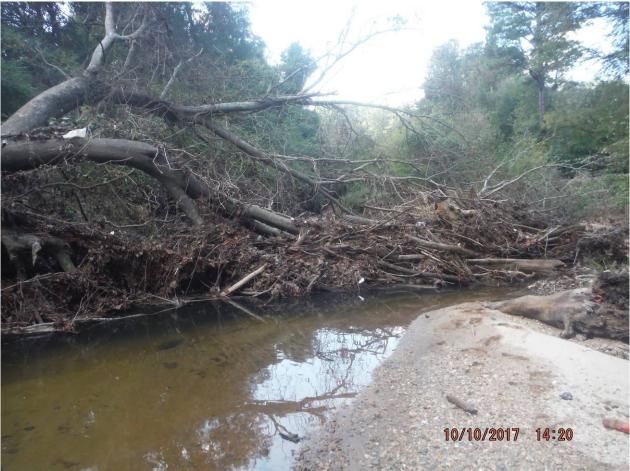
Figure 3-5 Main Stem Nancy Creek in Subwatershed NC05 at MP#1003.

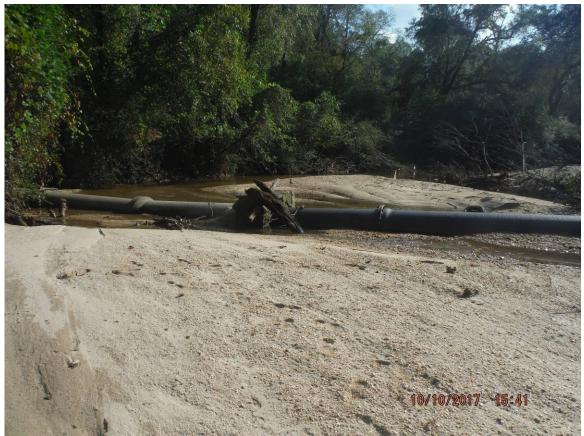
Figure 3-4 Main Stem Nancy Creek in Subwatershed NC06 (MP#1008)

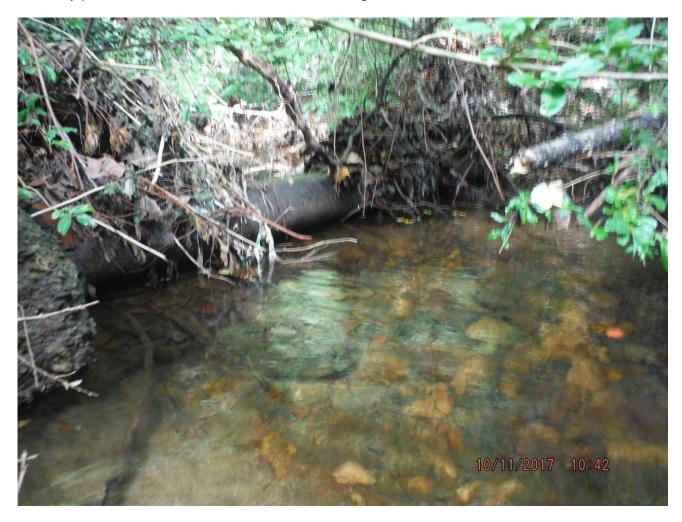
Figure 3-6 Debris Dam along the tributary in Subwatershed NC10 (MP#1011)

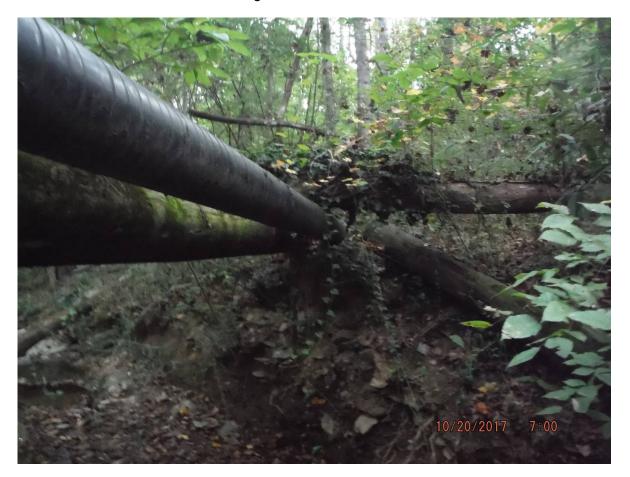
Figure 3-7 Fallen tree along tributary to Nancy Creek in Subwatershed NC08 (MP#1035)

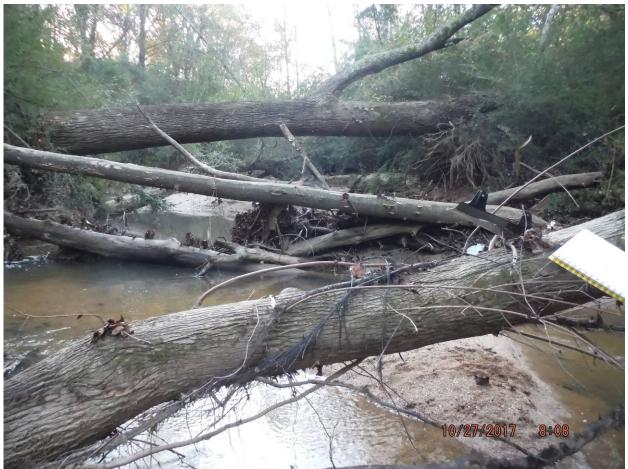
Figure 3-12 Crooked Creek Subwatershed JC05 (MP#1046)

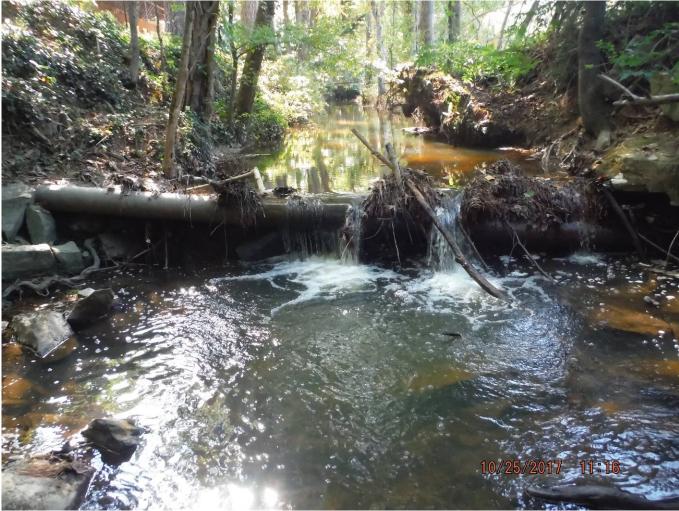
Figure 3-13 Ball Mill Creek Subwatershed BC59 (MP#1044)

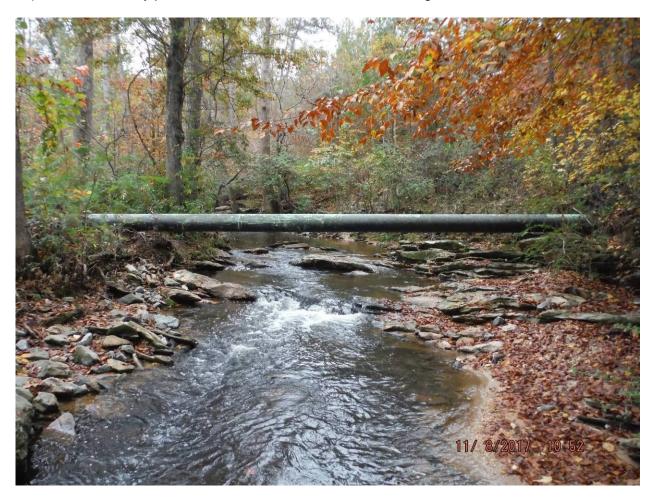
Figure 3-18 Sewer Crossing in Subwatershed MC03 (MP#1049)

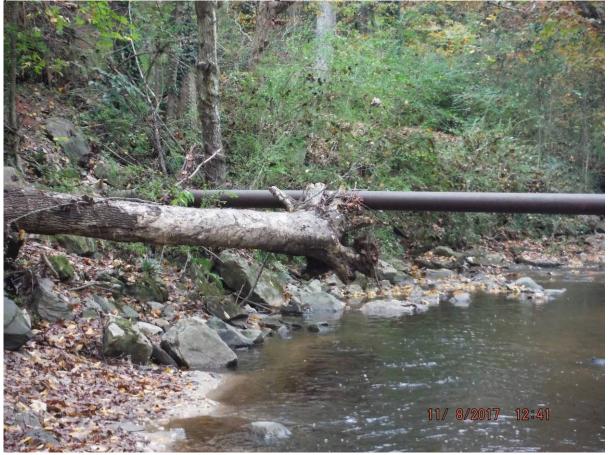
Figure 3-19 Sewer Crossing in Subwatershed MC04 (MP#1050)

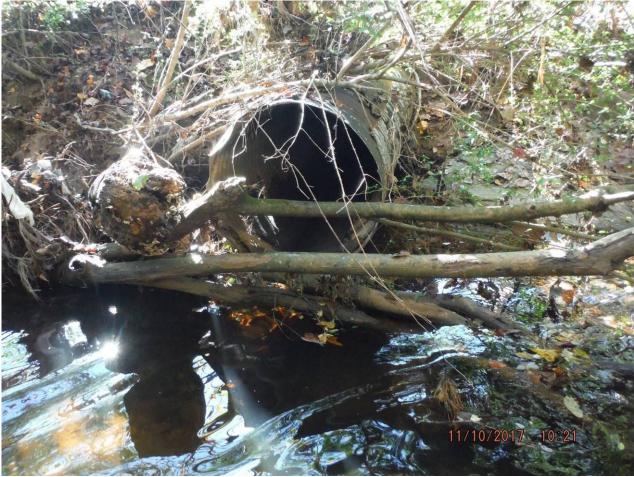
Figure 3-20 Stormwater Outfall in Subwatershed MC05 (MP#1058)

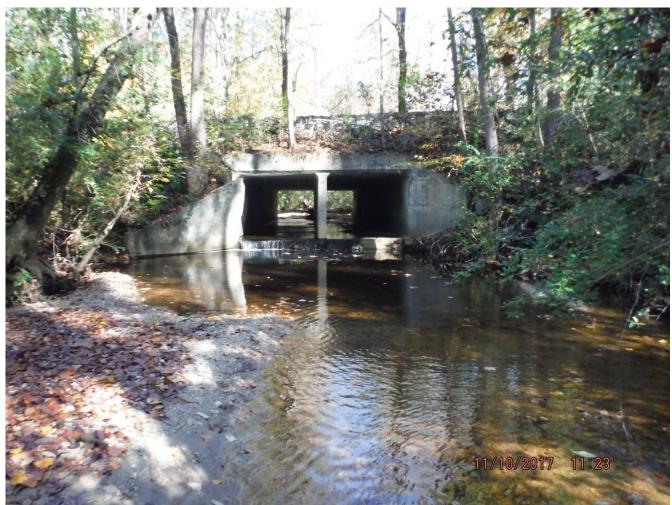
Figure 3-21 Glenridge Parkway Culvert and broken headwall in Subwatershed MC06 (MP#1061)

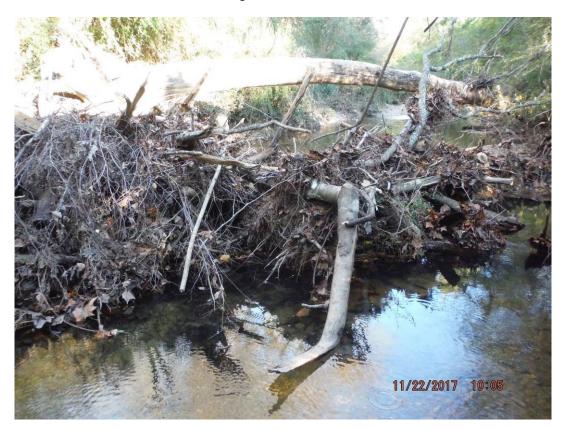
Figure 3-26 Debris Dam in Subwatershed LI01 (MP#1091)

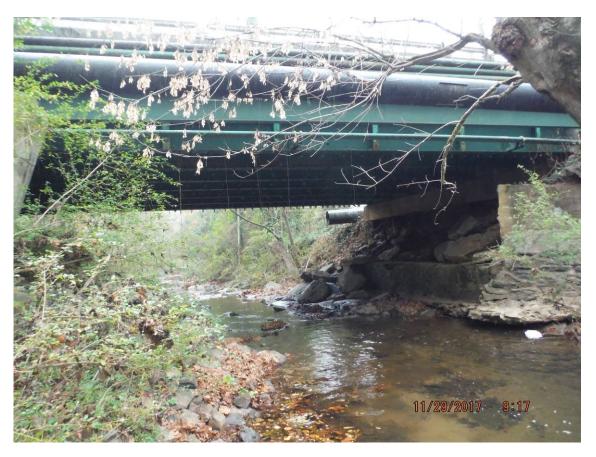
Figure 3-27 Structural damage to bridge footings in Subwatershed LI02 (MP#1092)

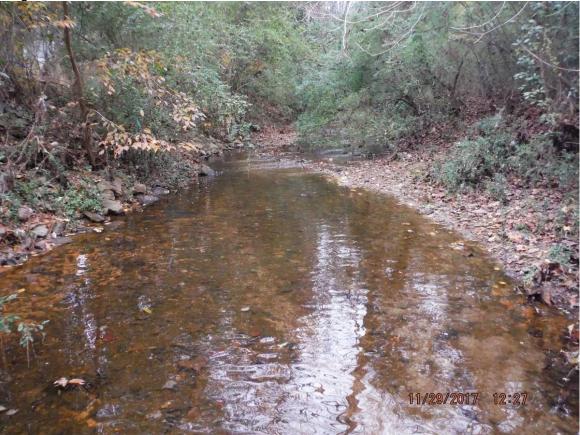
Figure 3-28 Long Island Creek Subwatershed LI03 (SPID#223)

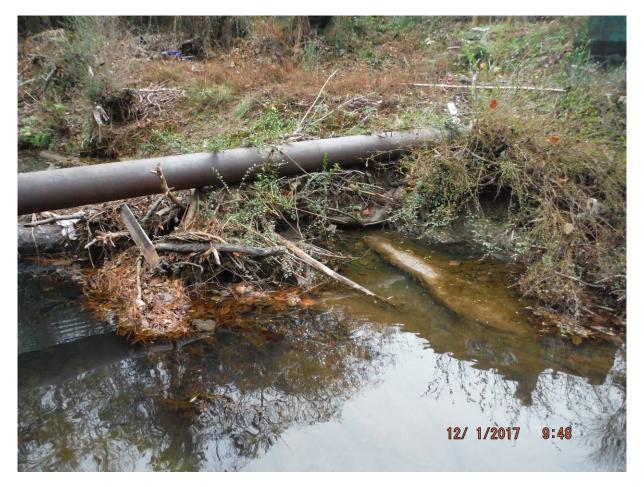
Figure 3-29 Debris Dam on Sewer Crossing in Subwatershed LI04 (MP#1093)

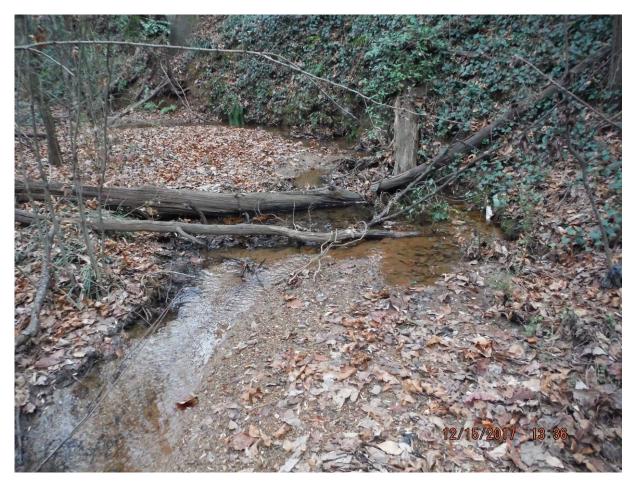
Figure 3-30 Tributary to Long Island Creek in Subwatershed LI05 (SPID#291)

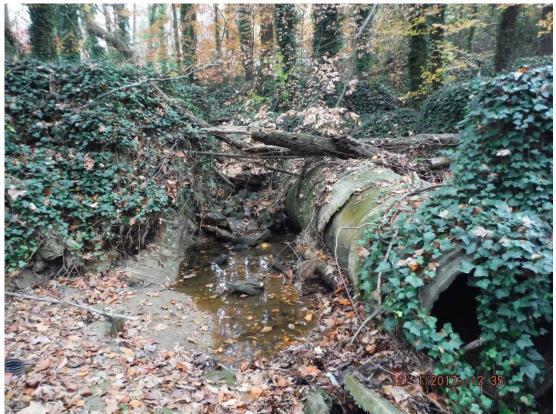
Figure 3-31 Concrete Pipe Debris in Subwatershed LI06 (MP#1098)
