Site Challenges

Existing Stone Building and Garage

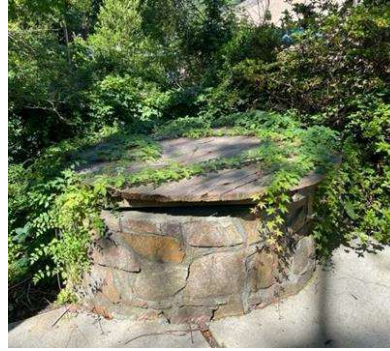
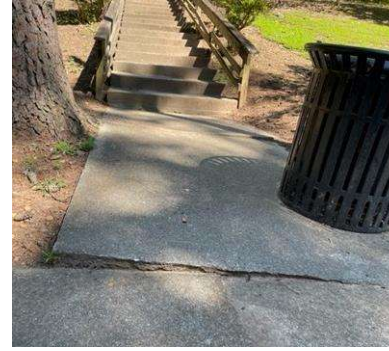
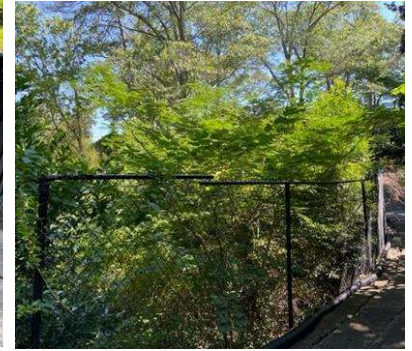
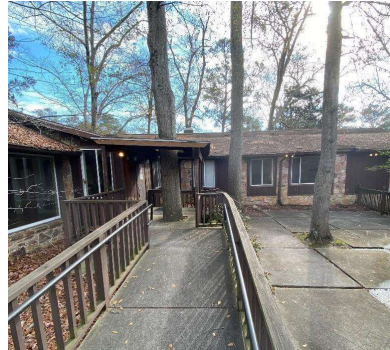
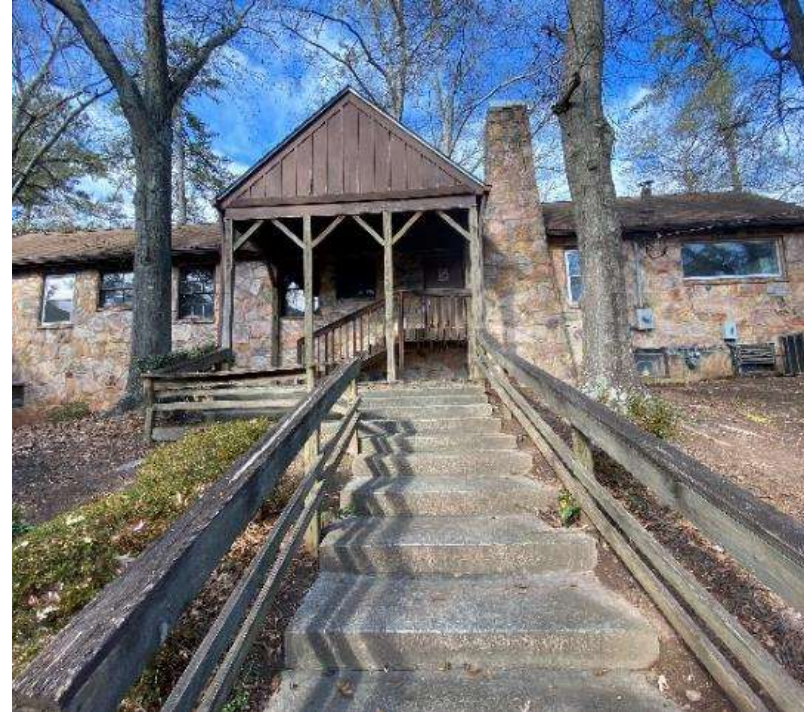
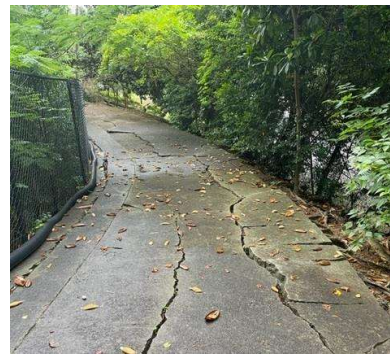
- Detention Pond conditions
- Active well is leaking
- Sidewalk conditions impact accessibility around the site
- Existing buildings impact tree root structures
- Unsafe building conditions (1930 stone building and garage)

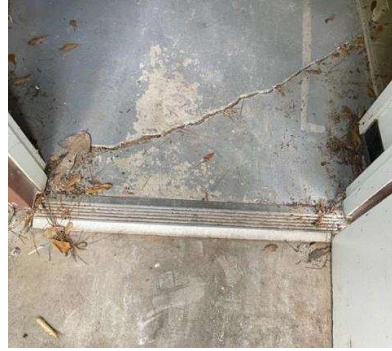
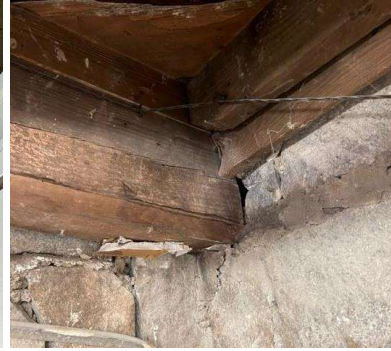
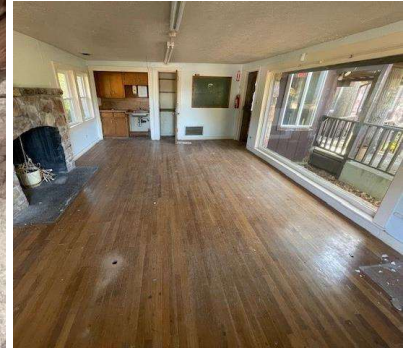
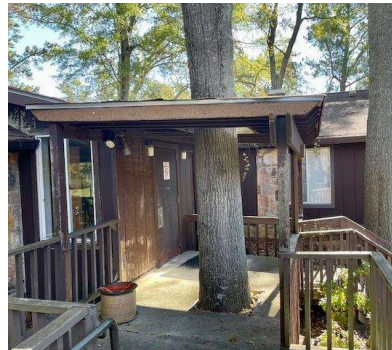
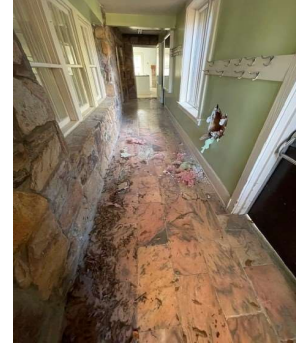
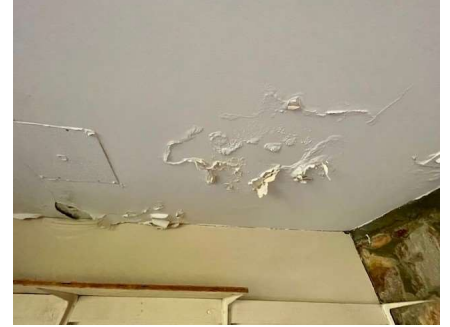
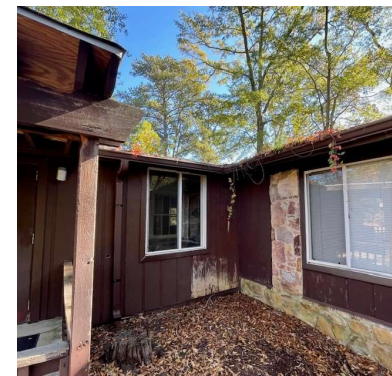
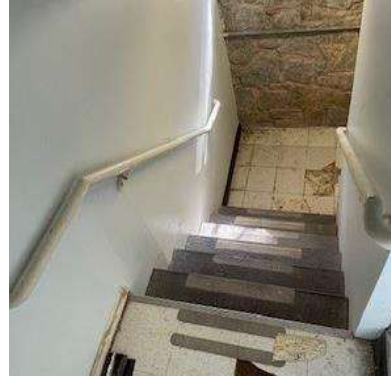
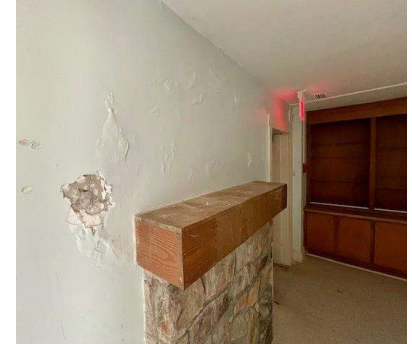
- Built in 1930's as a residence and repurposed in 1970's as a Visual Arts Center
- Structural failure of foundation walls, severe settlement cracks, joist and beam separations
- Neither building meets ADA Accessibility requirements
- Outdated electrical and plumbing systems
- Traces of Asbestos found
- Compromised Arts Instruction spaces
