The goal of this study is to develop a watershed improvement plan that targets the reduction of fecal coliform bacteria in the Crooked, Ball Mill and Marsh Creek watersheds in addition to the tributaries draining directly into the Chattahoochee River. The plan developed to meet this goal is outlined in this report, the Fecal Coliform Watershed Improvement Plan (WIP). The Fecal Coliform WIP outlines the methods, results and recommendations aimed at improving and where possible restoring watershed function. This goal is achieved by implementing management activities and projects to meet specific water quality and/or habitat improvement goals.

This report outlines the background, methodology, and results of the Fecal Coliform WIP. The Fecal Coliform WIP will satisfy municipal separate stormwater sewer system (MS4) Phase II, Metro District, and Total Maximum Daily Load (TMDL) Plan requirements as well as identify projects that will improve watershed conditions. The report is organized into the following chapters:

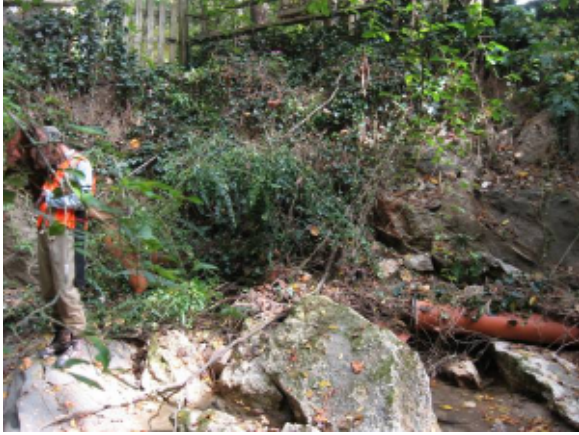
Bank failure exposed and cracked clay sewer line

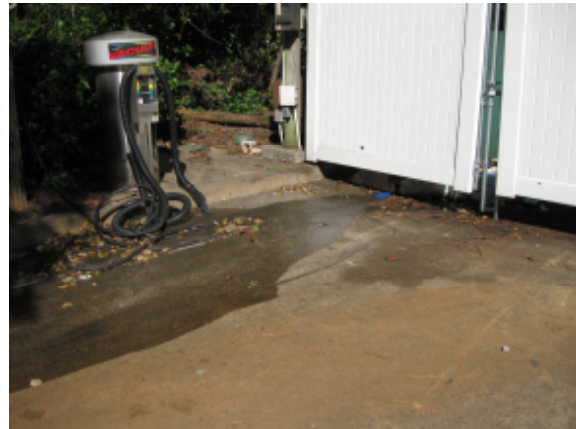
Drainage from a dumpster flowing into stream

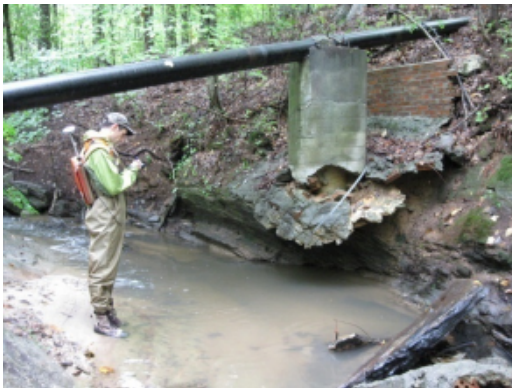
Undermined sewer crossing support

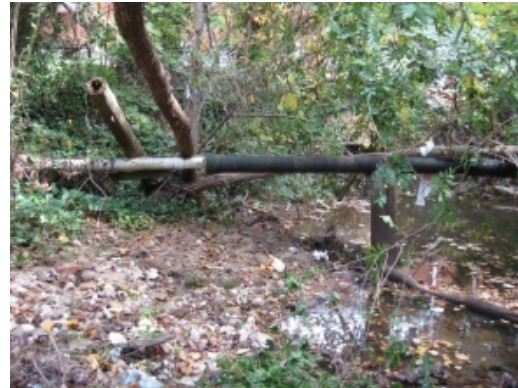
Exposed PVC sewer pipe with debris loading

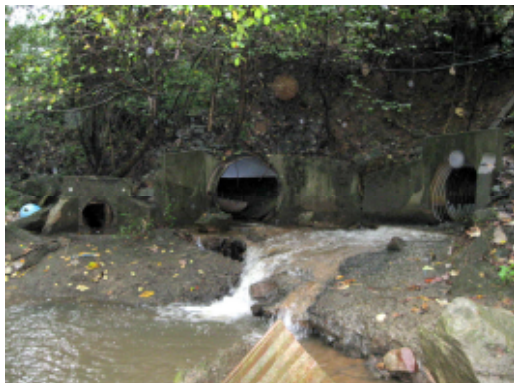
Several outfalls draining commercial and high density residential land near Northridge Crossing Drive

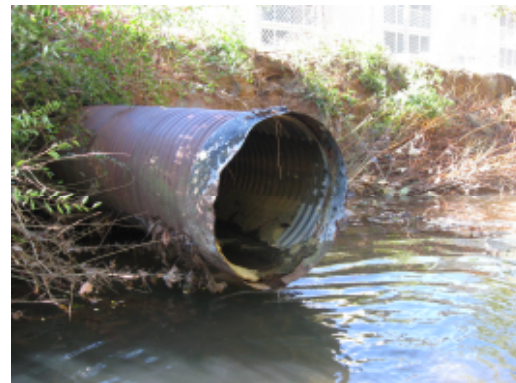
Stormwater outfall on Marsh Creek near 550 Abernathy Road

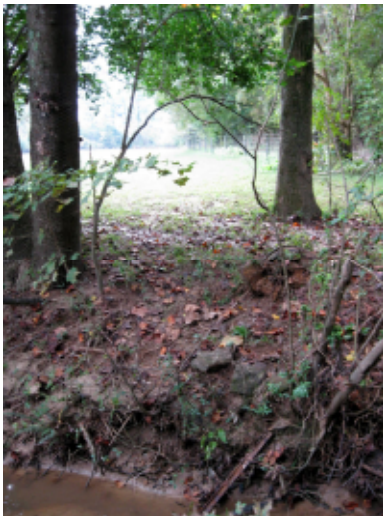
Horse pasture on western side of Crooked Creek with minimal buffer and ditches draining directly into stream

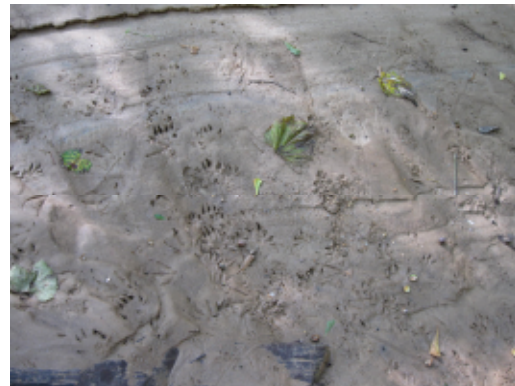
Raccoon and rodent prints in stream bed observed throughout the study area

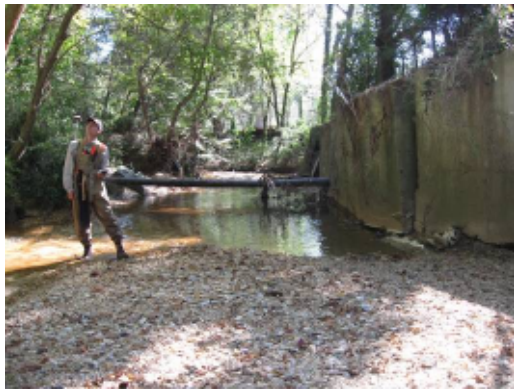
Channelized reaches were observed in densely developed areas such as this stream crossing with Roswell Road

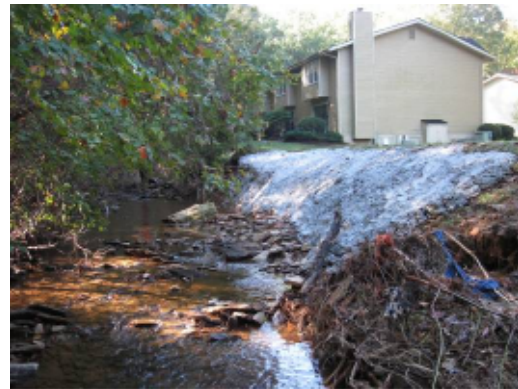
Riprap lined banks were the most commonly observed man-made alteration

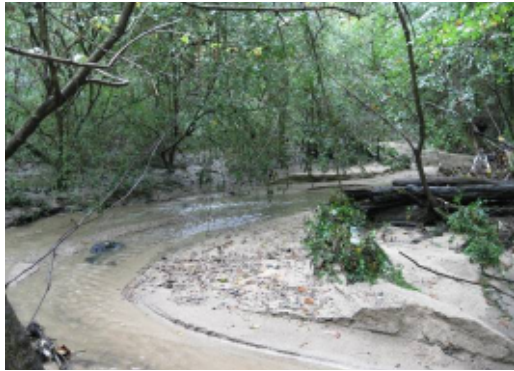
Sediment deposits in the form of sand and gravel bars and islands indicative of channel aggradation

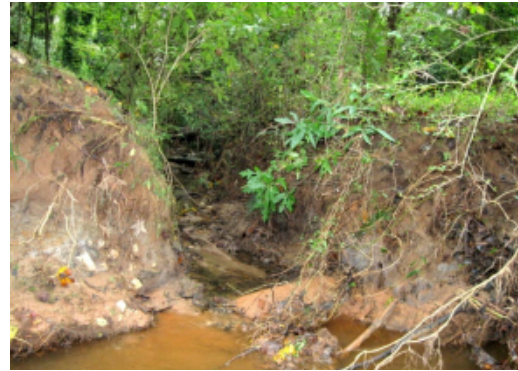
A tributary incised to match bed elevation of main stream

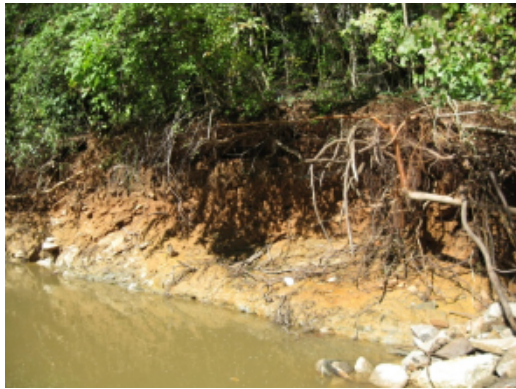
Example of bank erosion in the 75-100% range

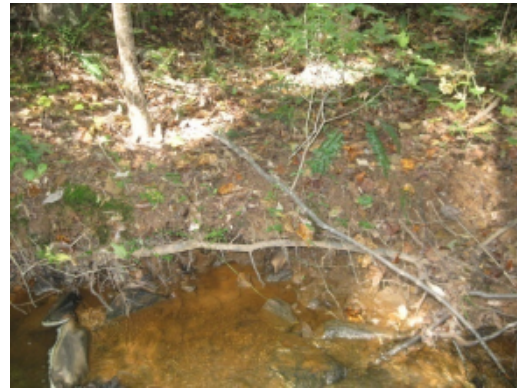
Example of bank erosion in the 25-50% range

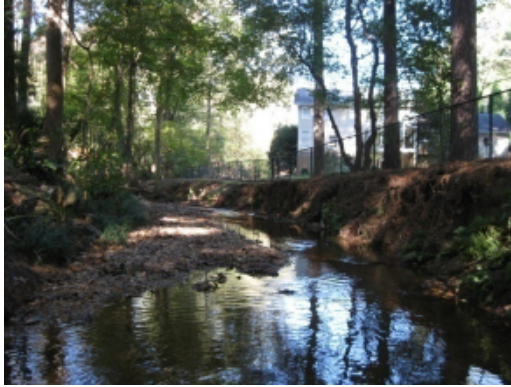
Buffer encroachment was common in residential areas with grassed lawns directly adjacent to streambank

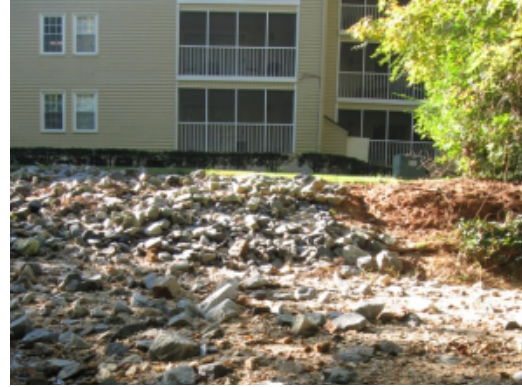
Impervious surface and structure encroachment was second-most common buffer encroachment observed

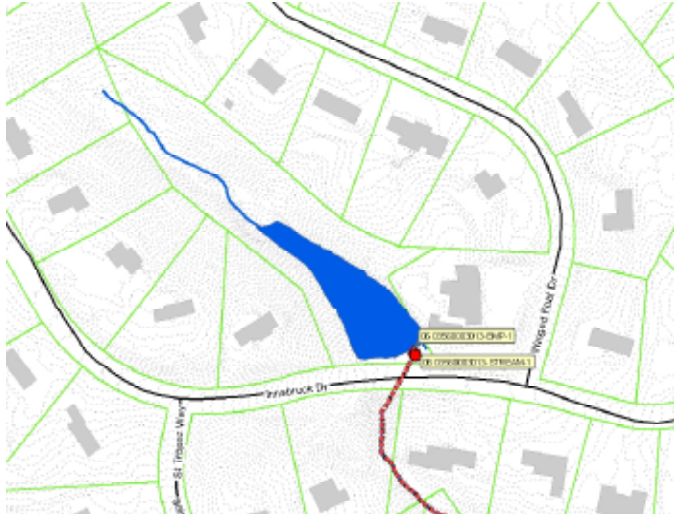
Proposed site of existing stormwater BMP that could be modified to increase water quality benefits off Innsbruck Drive

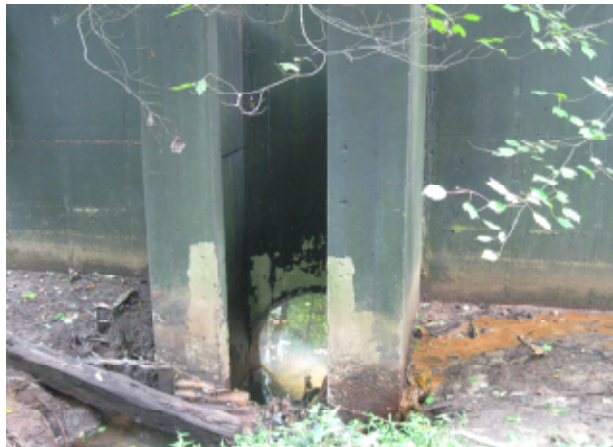
Modification of this outlet structure would increase water quality benefits as part of project 17 0024 LL084-BMP-1

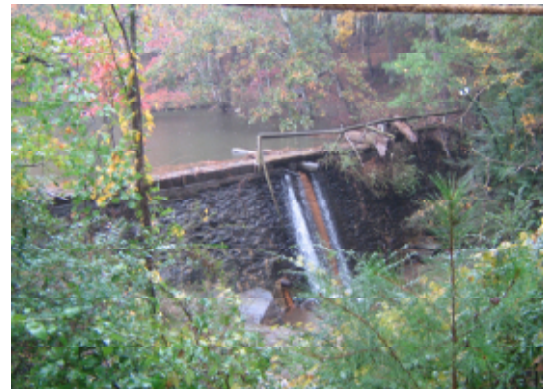
Water quality and channel protection benefits could be achieved by re-designing the outlet control structure at this existing pond as part of Project 06 0353 LL012-BMP-1

Project 06 0353 LL012-BMP-1 is an example of a project within the “single family residential non-attached” category (not currently within the City’s level of service). The project includes retrofitting an existing wet pond. The existing BMP is located in a residential area near Grapevine Run. This proposed retrofit will achieve full water quality and a portion of the channel protection benefits by building or significantly redesigning the outlet control structure of the wet pond. The permanent pool may need to be lowered to achieve these benefits.

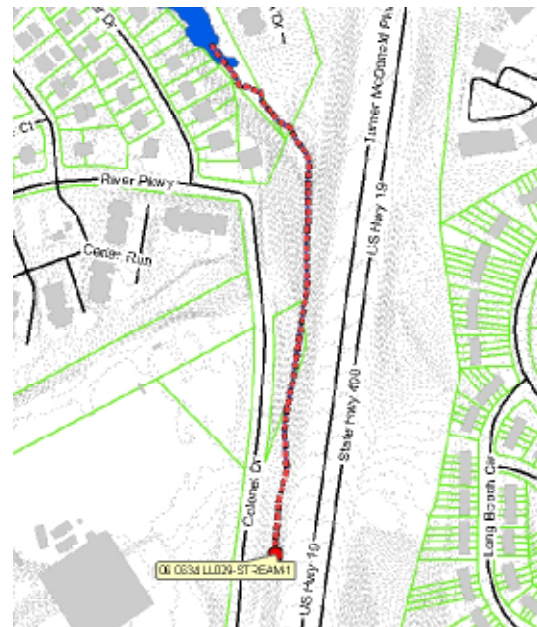
Location of a potential stream restoration project near Dunwoody Middle School and GA 400
