SANDY SPRINGS STREAM ASSESSMENT PRESENTATION

05/15/2018

City of Sandy Springs
Stream Assessment

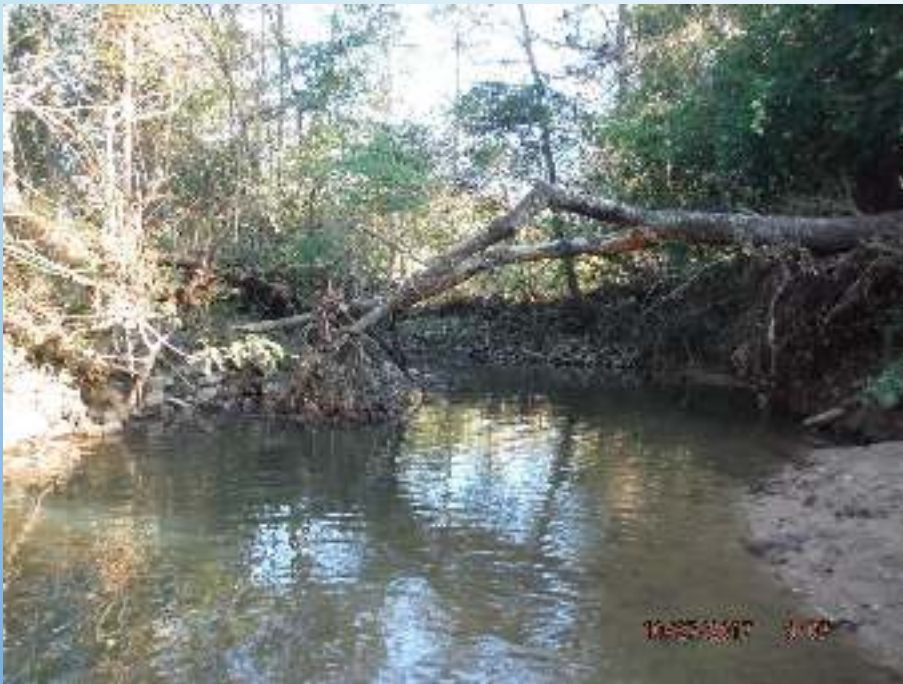
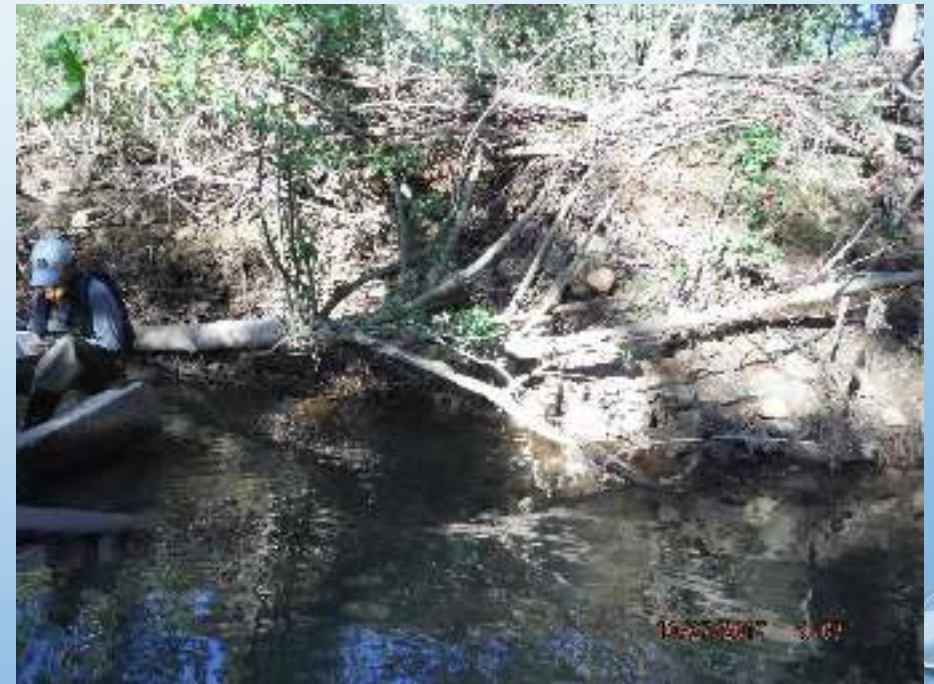
REPRESENTATIVE REACH POINT 8 (LOWEST HABITAT SCORE)

Crooked Creek

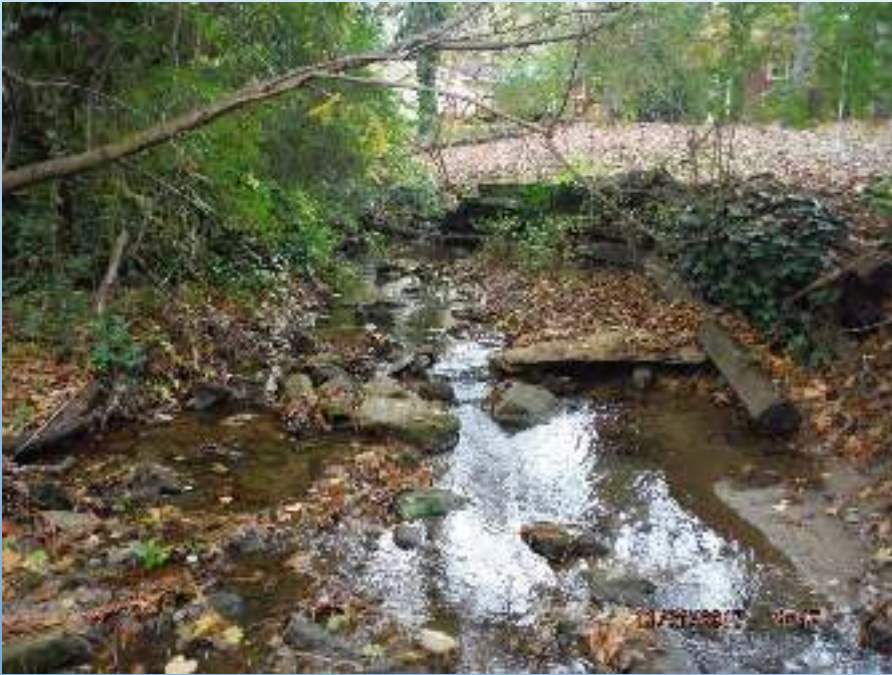
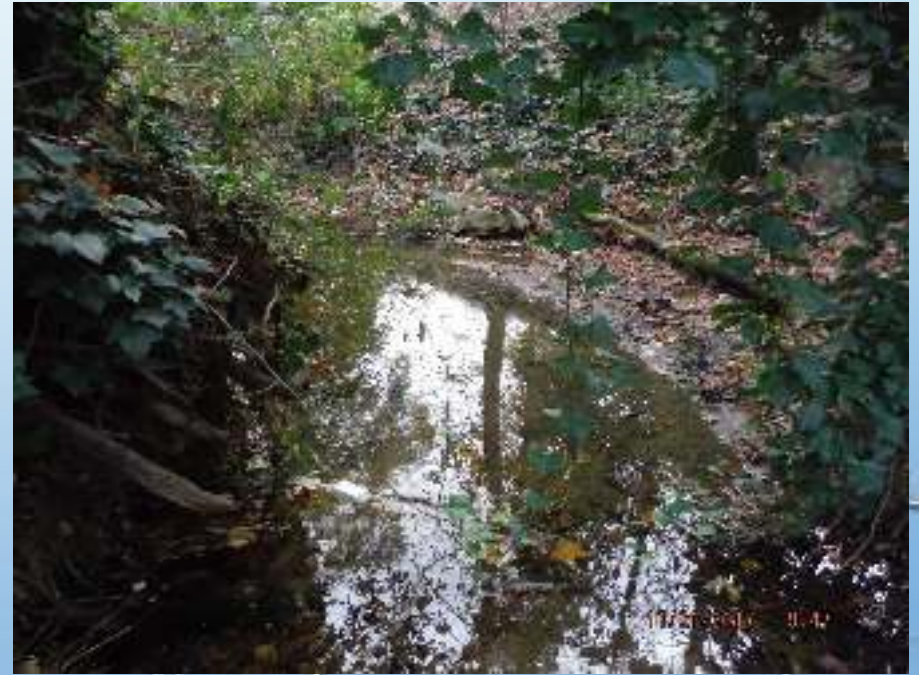
REPRESENTATIVE REACH POINT 11 (HIGHEST HABITAT SCORE)

Marsh Creek Tributary

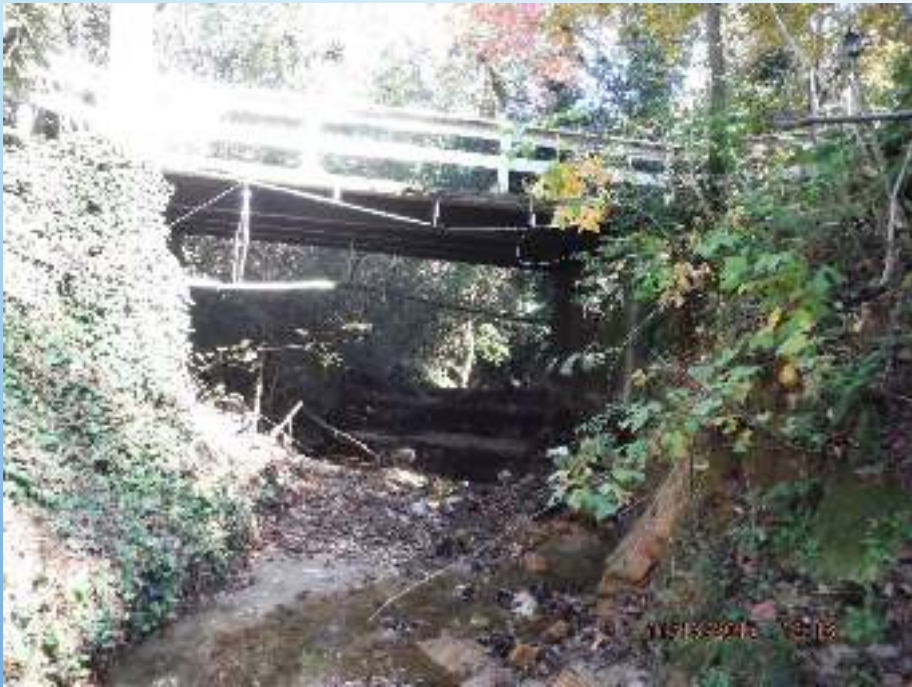
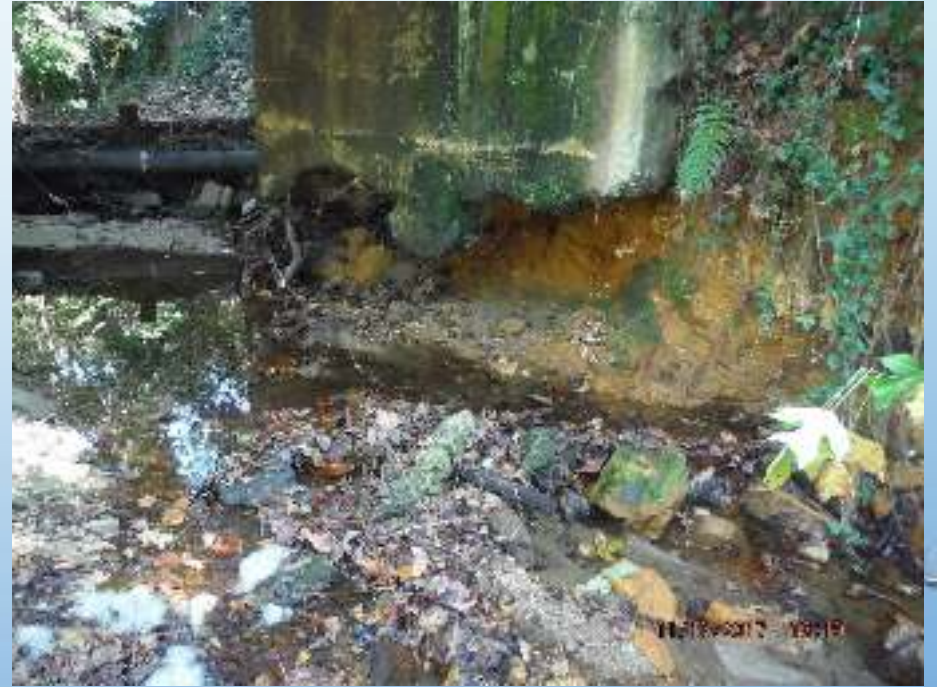
MAINTENANCE POINT 1066

Eroded Infrastructure Support near Hunters Branch Drive (Private Property) Marsh Creek

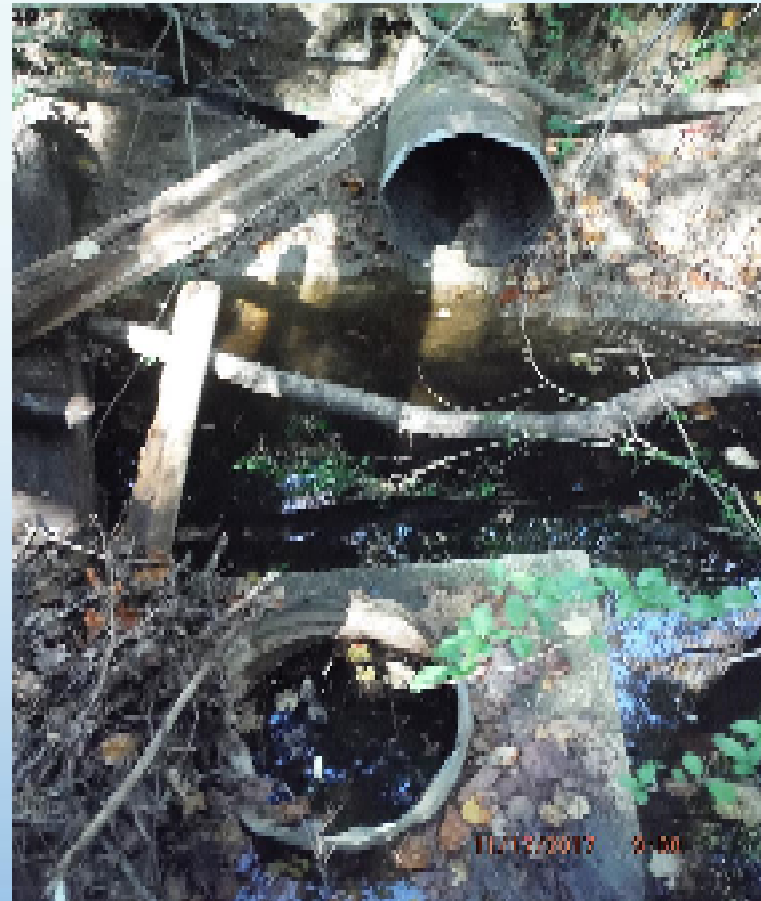
MAINTENANCE POINT 1077

SEPARATED STORM DRAIN HEADWALL NEAR
VERNON GLEN COURT (PRIVATE PROPERTY)
MARSH CREEK

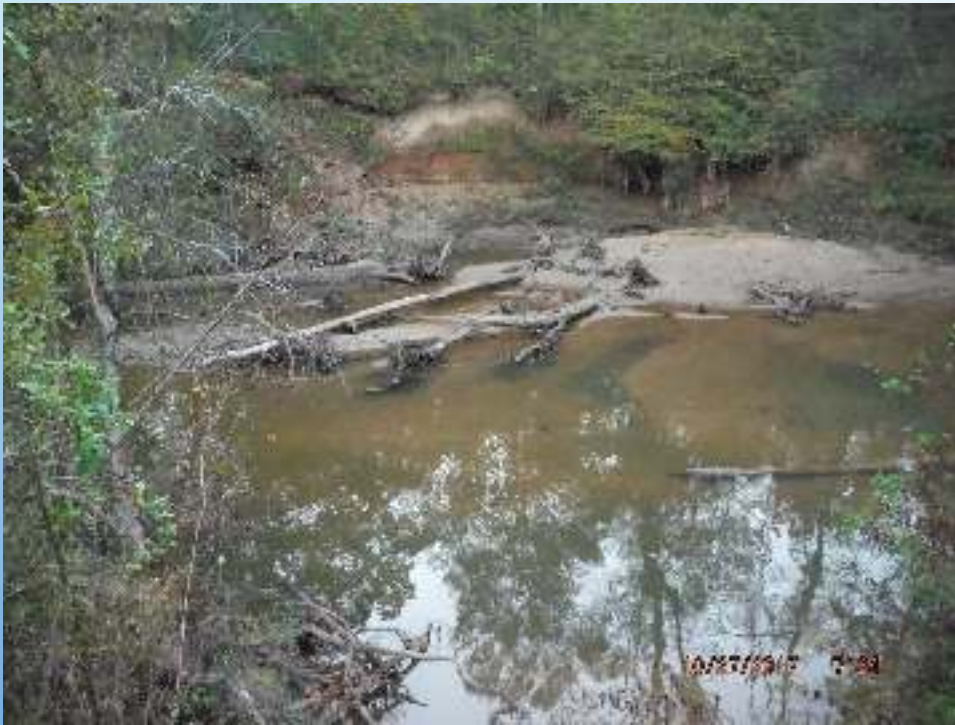
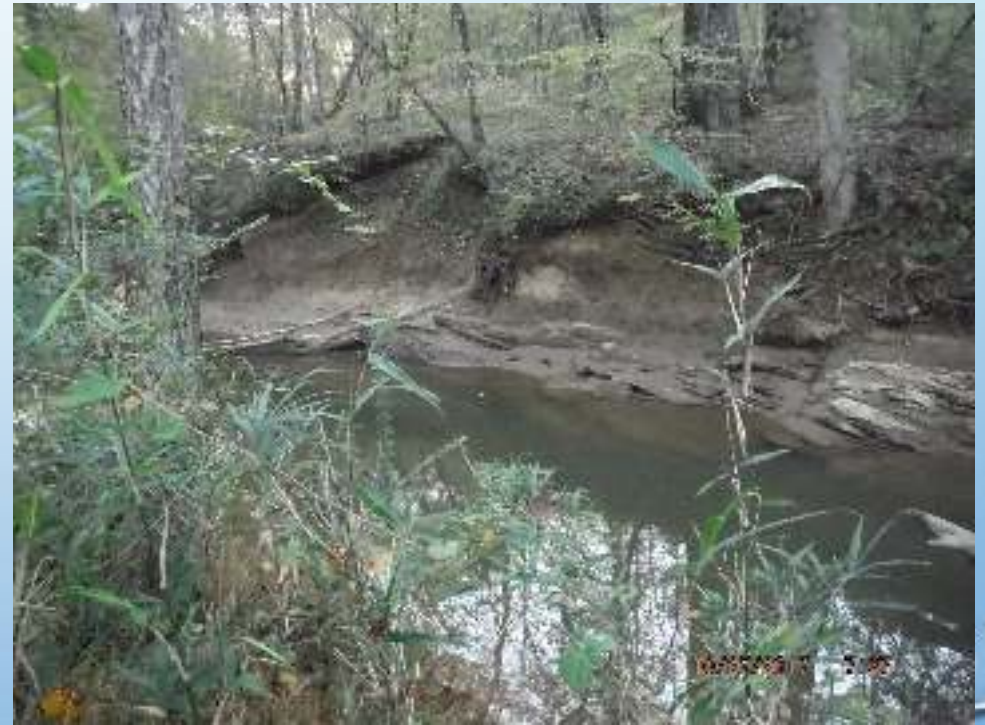
MAINTENANCE POINT 1046

Eroded stream banks – Crooked Creek at the confluence with Chattahoochee River (Private Property)

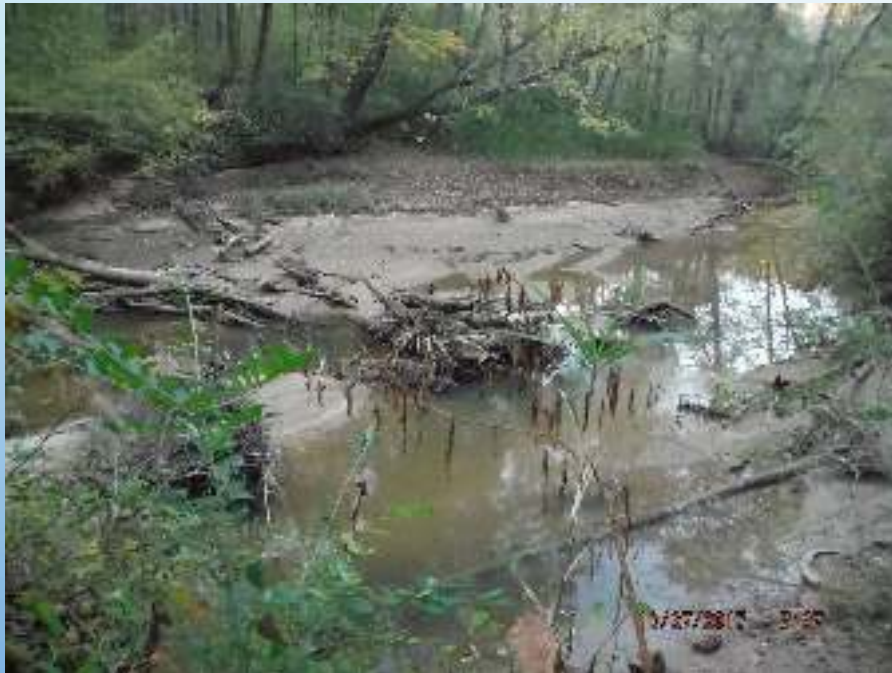
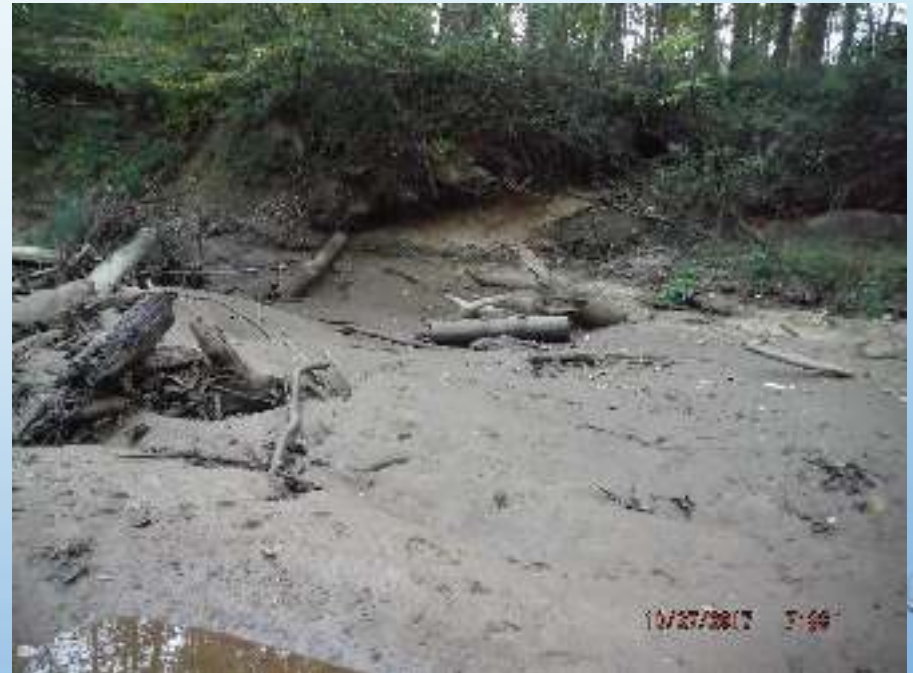
MAINTENANCE POINT 1046

Eroded stream banks – Crooked Creek at the confluence with Chattahoochee River (Private Property)

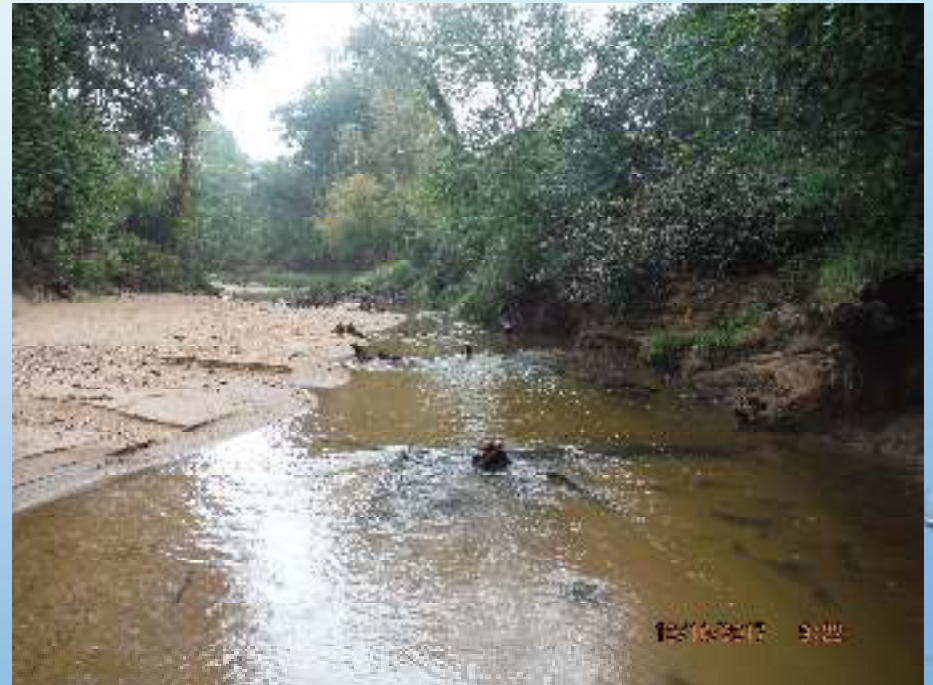
Nancy Creek

CHANNEL EVOLUTION MODEL (CEM) STAGE

Stage	Description
1	Stable/Undisturbed
2	Initial Disturbance
3	Incision
4	Incision and Widening
5	Aggradation
6	Equilibrium

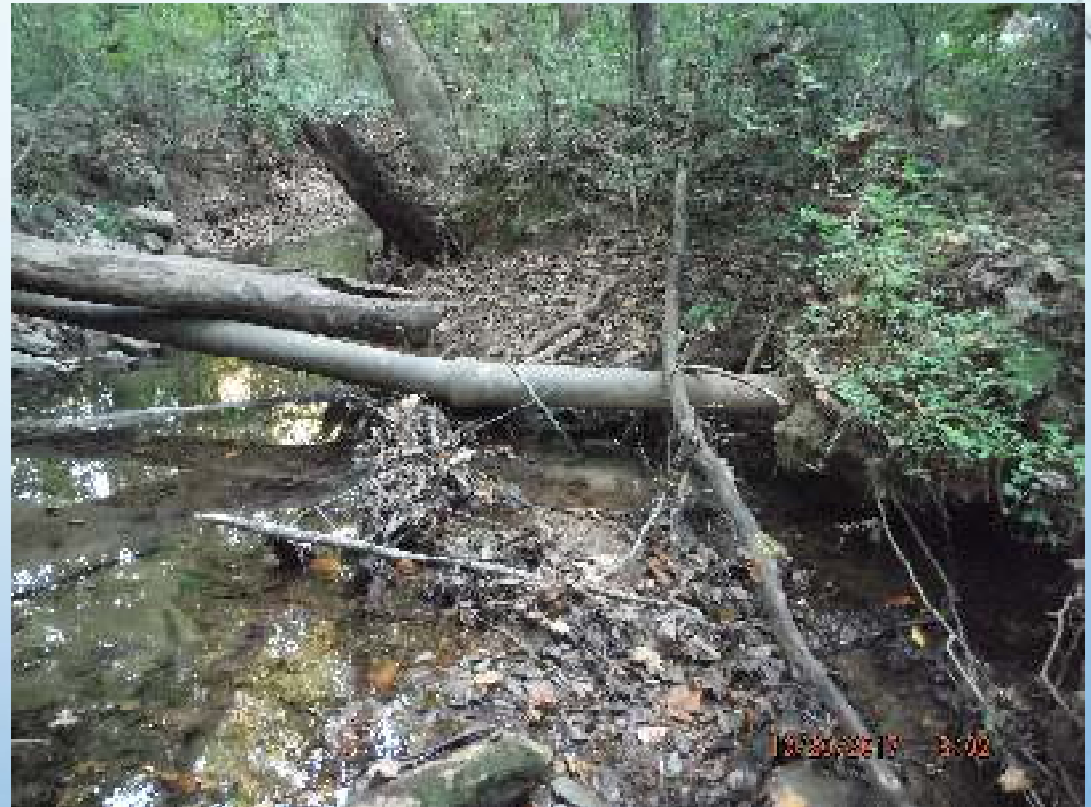
Nancy Creek Tributary

POLLUTION SOURCES

POINT SOURCE

- SEWER LINE/SSO
- CHEMICAL DISCHARGE
- ILLICIT STORM WATER DISCHARGE

NON-POINT SOURCE

- LIVESTOCK
- AGRICULTURAL RUNOFF
- PRIVATE PET WASTE IN RESIDENTIAL AREAS

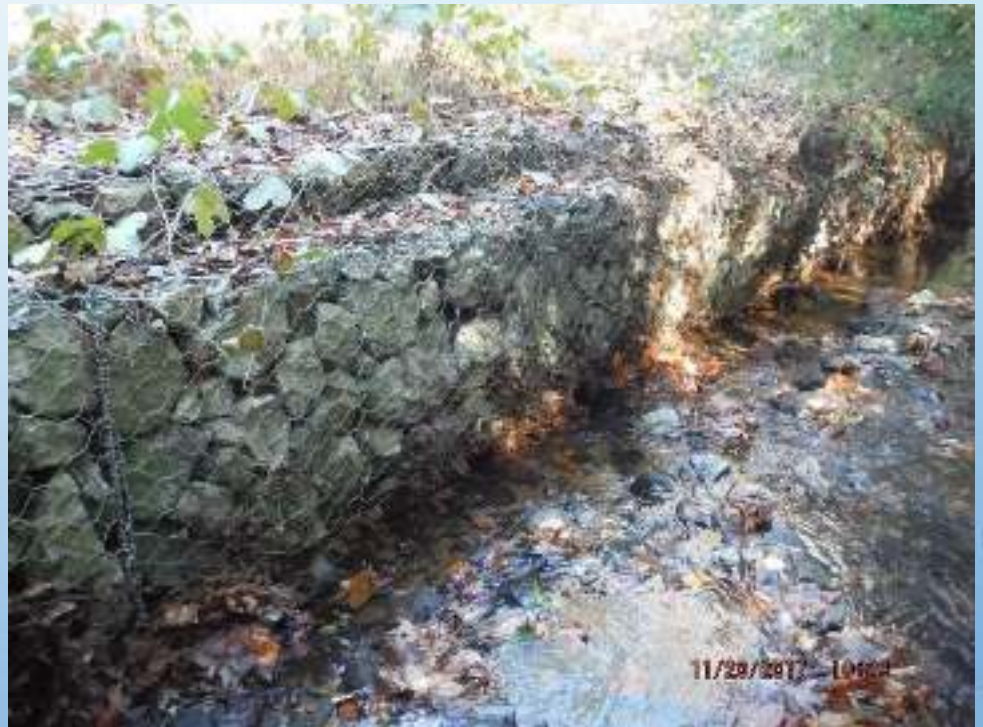
CHANNEL ALTERATIONS

- CHANNELIZED REACH
- PIPED REACH
- RIP-RAP CHANNEL
- GABION BASKETS
- FLOODPLAIN BUILT UP
- CONCRETE CHANNEL

Marsh Creek Tributary (Private Property)

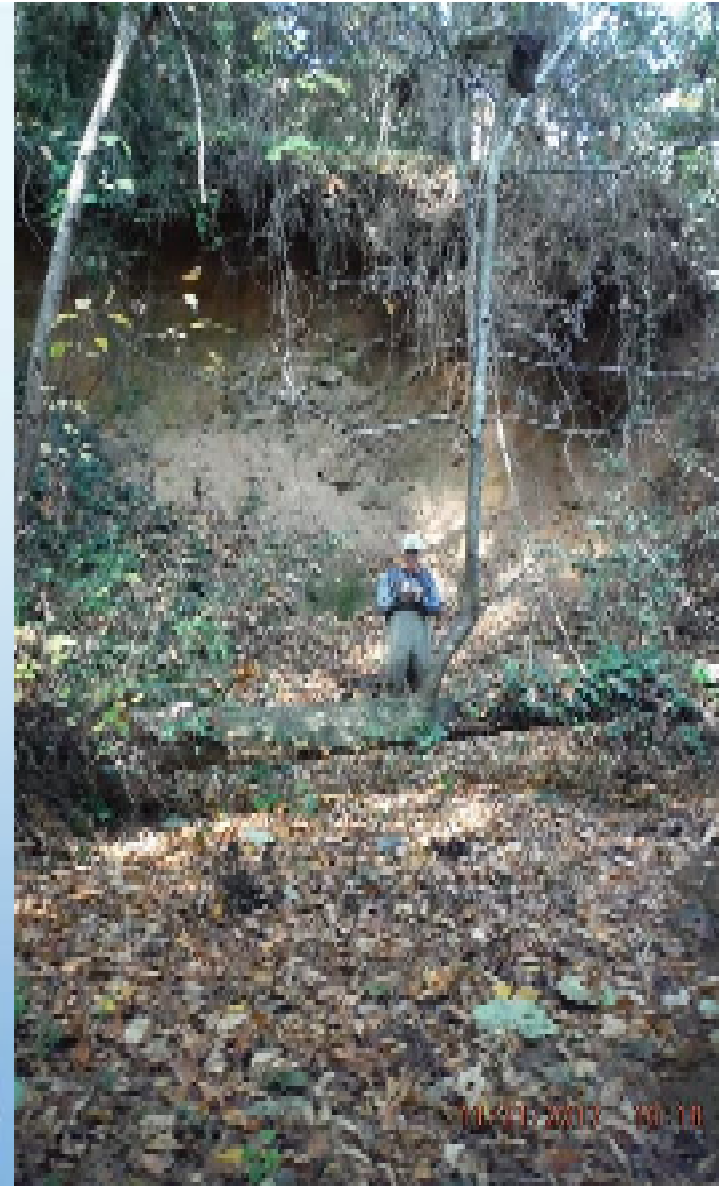
STREAMBANK EROSION

- PERCENT EROSION
- LENGTH OF EROSION
- AVERAGE BANK HEIGHT

Marsh Creek Tributary

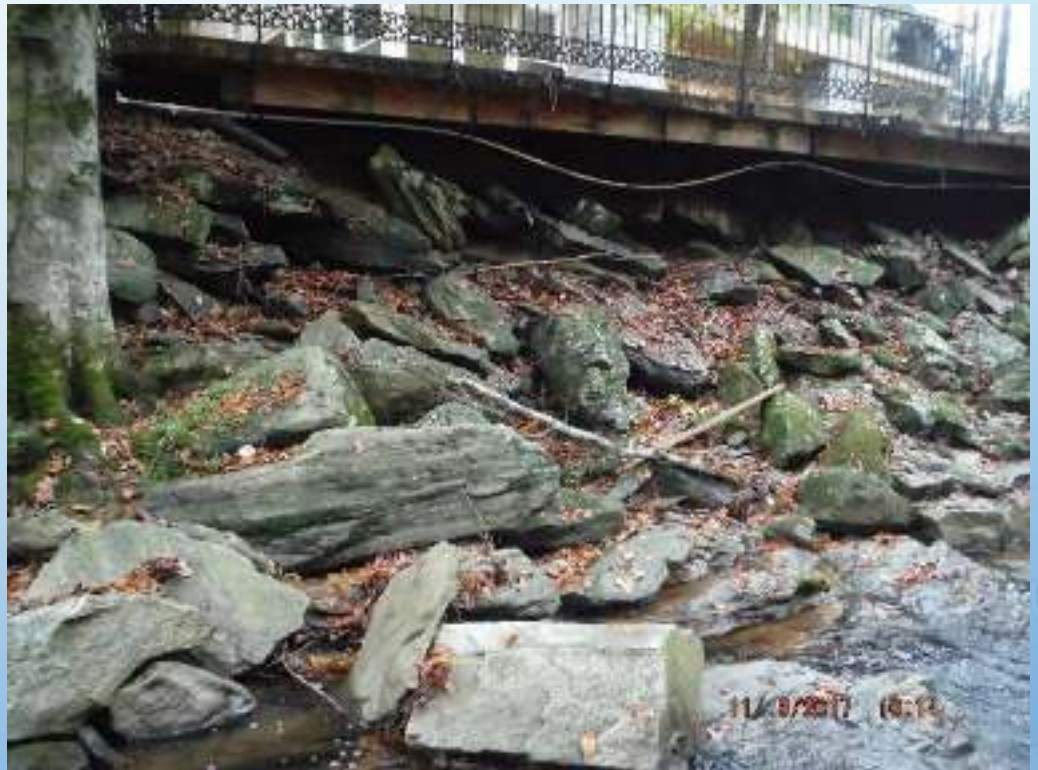
STREAM BUFFER ENCROACHMENTS

- ALTERED VEGETATION
- IMPERVIOUS COVER
- LANDSCAPING
- STRUCTURES
- UTILITIES

Marsh Creek (Private Property)

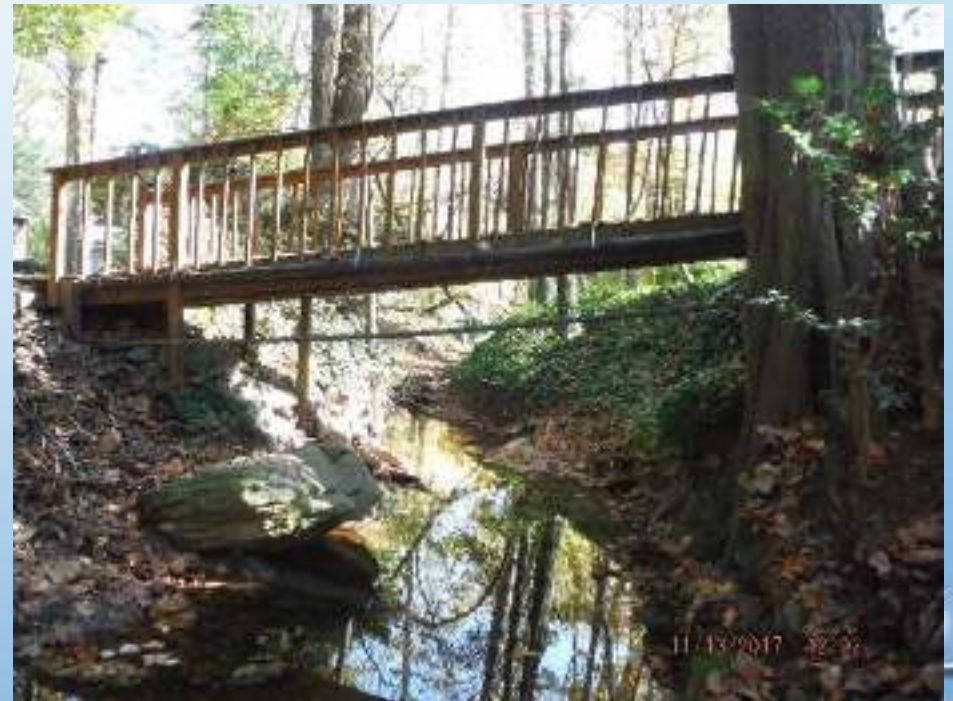
Marsh Creek Tributary

COMMENTS

- INVASIVE SPECIES
- RAIL ROAD/ROAD/PRIVATE DRIVE CROSSINGS
- TRIBUTARY CONFLUENCES
- SEWER LINE CROSSINGS
- STORM WATER OUTFALLS
- BMPS

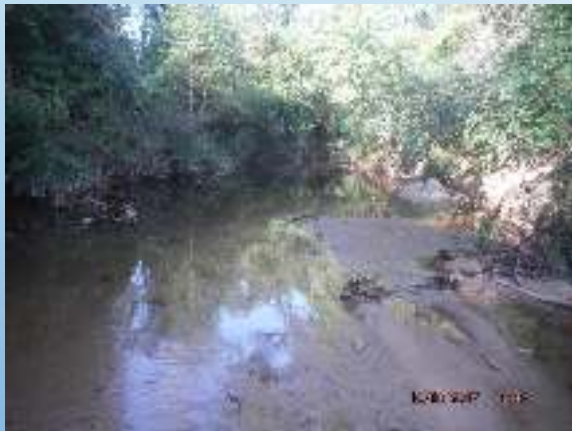
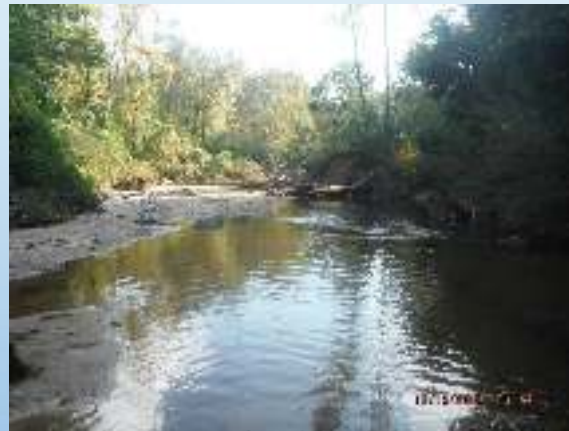
STREAM POINT 0019

CEM Stage	5
Bed Texture	Sand
Bank Texture	Clay
Aggradation	400
Aggradation Severity	Heavy
Insision and Widening	400

Nancy Creek at jurisdictional boundary with DeKalb County

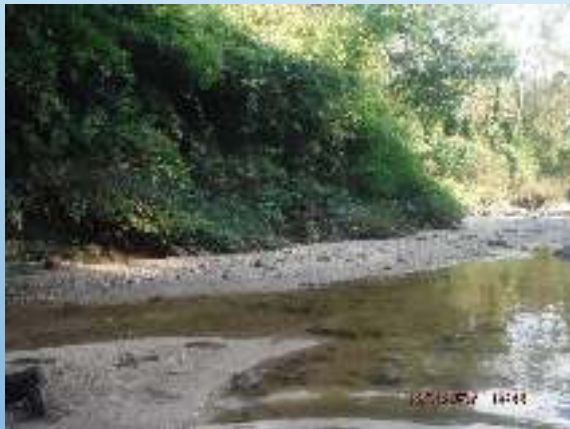
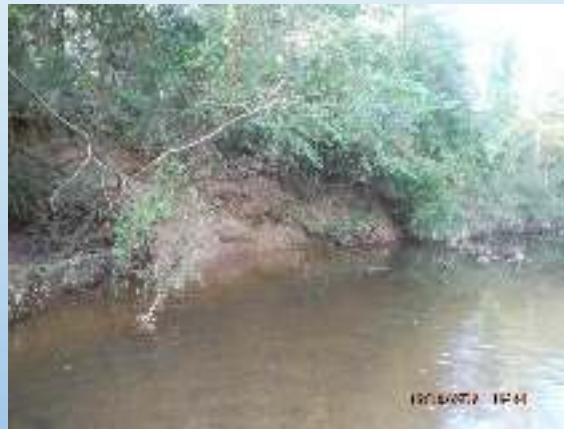
STREAM POINT 0019

Left Bank Erosion	50-75%
Left Bank Length	350
Left Bank Height	11'
Left Bank Slope	60-90*
Right Bank Erosion	75-100%
Right Bank Length	250
Right Bank Height	10
Right Bank Slope	60-90*
Bank Full Height	3

Nancy Creek at jurisdictional boundary with DeKalb County

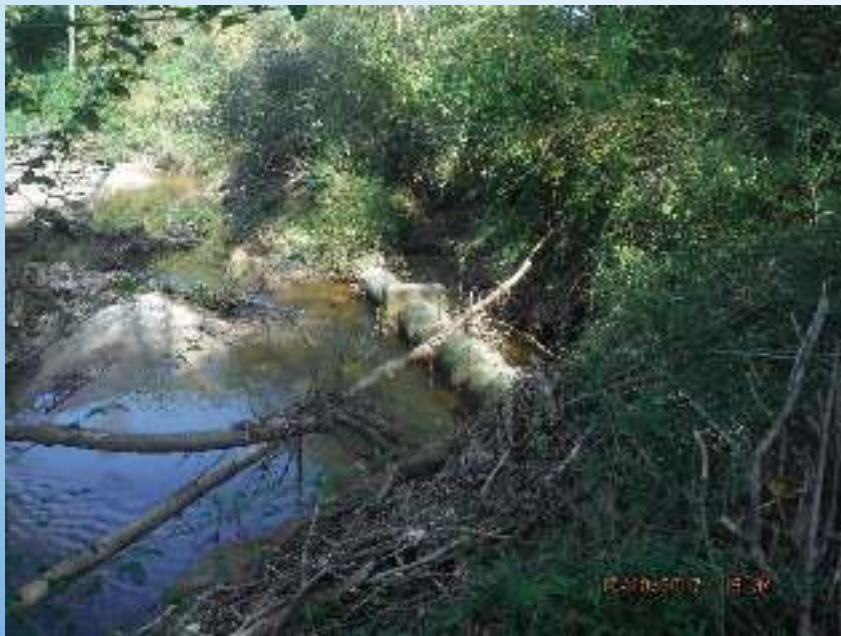
BONUS PHOTO 3244

Nancy Creek at jurisdictional boundary with DeKalb County
