FULTON COUNTY  
DEPARTMENT OF  
PUBLIC WORKS

# Water Resources Management Program

## Volume 7 - Sandy Springs Study Area

June 2001

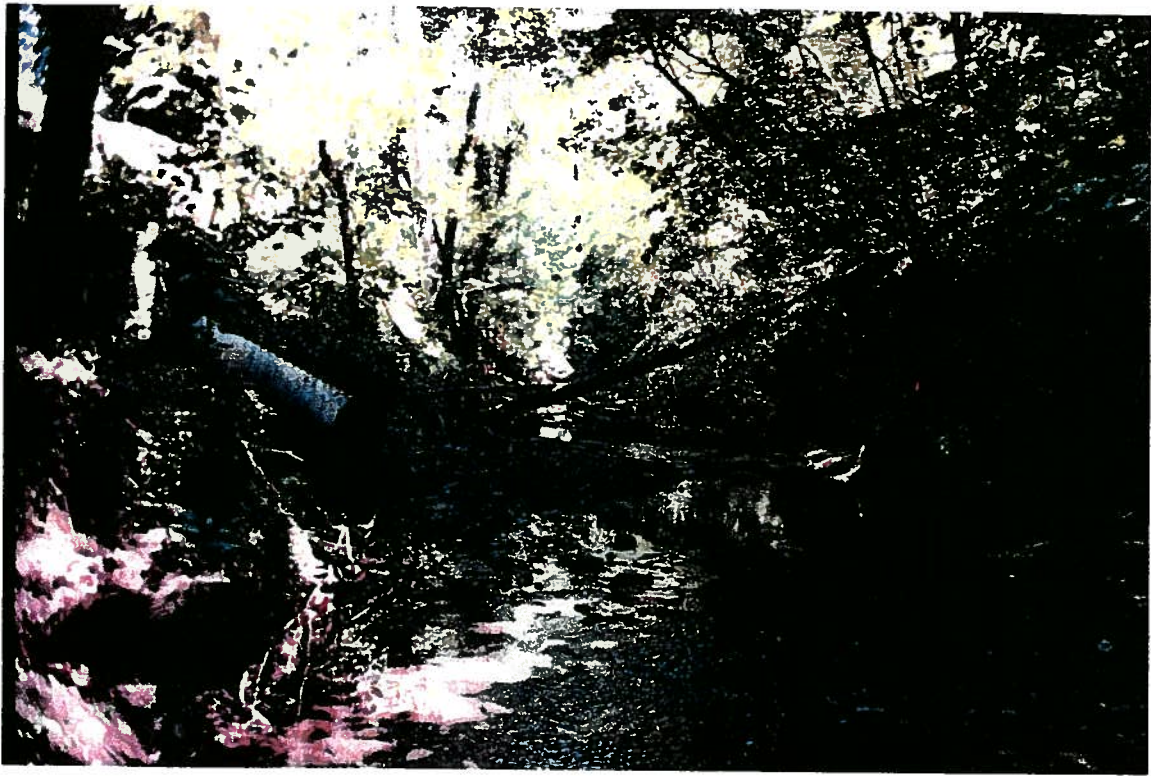
**PHOTO 5 - REPRESENTATIVE VIEW OF SS-4, GAME CREEK  
(Note large pipe draining into stream.)**

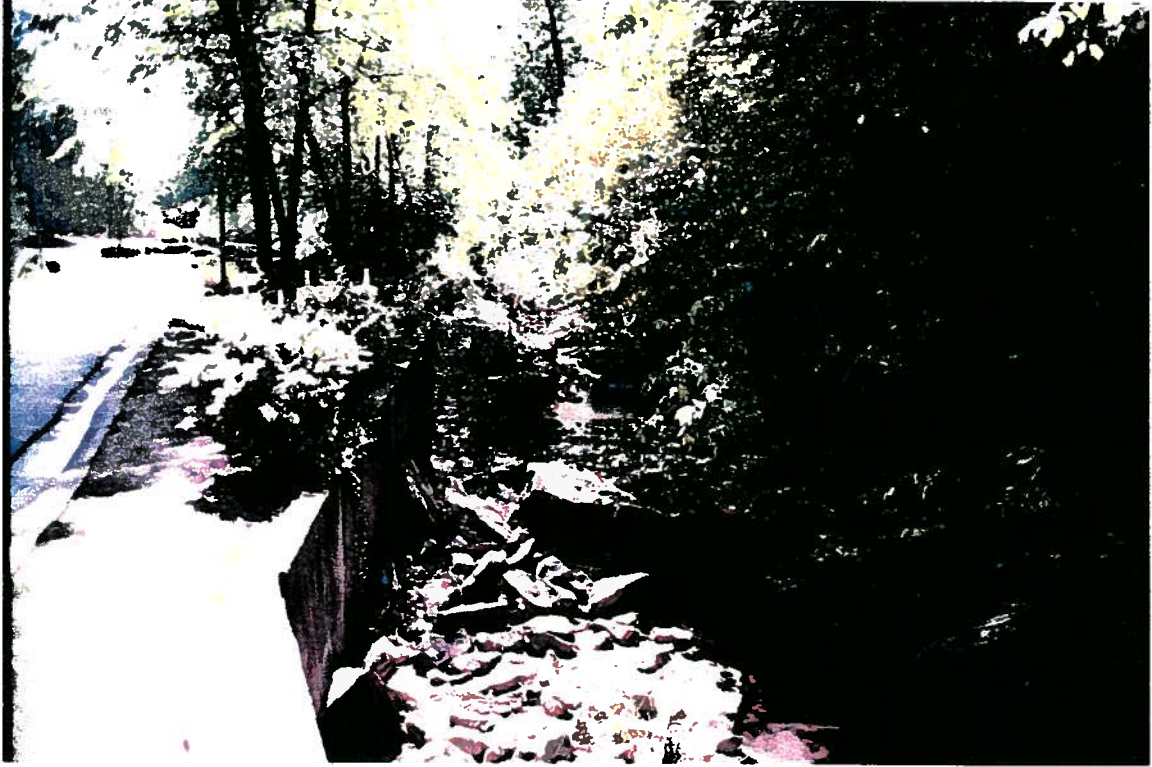
**PHOTO 19 - REPRESENTATIVE VIEW OF SS-7, POWERS BRANCH  
(Note pipe and retaining wall in creek and adjacent roadway.)**
