1. WATERSHED CHARACTERISTICS

Figure 1-1. Watershed Delineation
Long Island Creek Watershed Improvement Plan

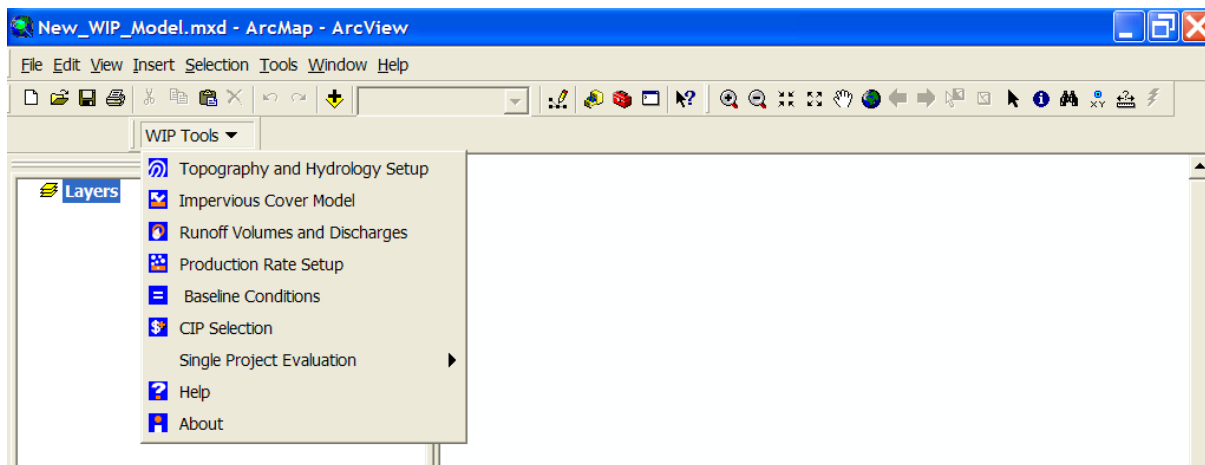
WIP Tools Menu Items

WIP Tools is a raster based project evaluation and water quality model deployed as an extension in ArcGIS. It was created by Brown and Caldwell to aid in the development of a Capital Improvement Plan (CIP) for Watershed Improvement Planning. WIP Tools allows for the analysis of multiple ‘what-if’ scenarios in which a user can ‘turn-on’ projects, generated results and then try another set of projects. The raster based format allows projects to be placed and evaluated, and results to be extracted anywhere in the study area. The WIP Tools model works in a systematic manner starting at the top menu item and moving downward (see image below). Each of the following sections gives an overview of the key inputs and results by WIP Tools menu item. More details on the equations and methodology in the WIP Tools model may be found in the WIP Tools User’s Guide located in Appendix F.

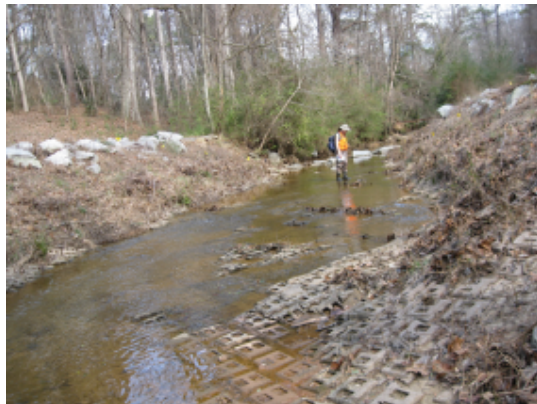
Riprap lined banks were the most common man-made alteration observed

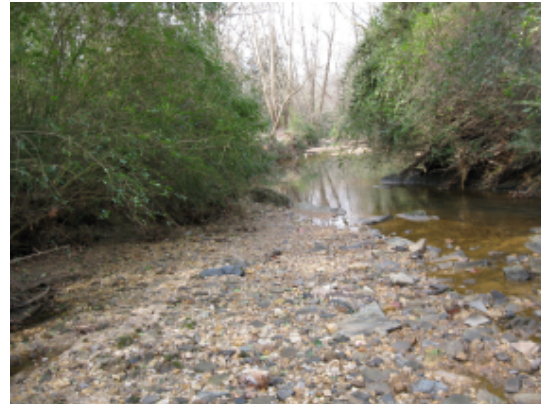
Example of channel aggradation, the most common hydrologic alteration

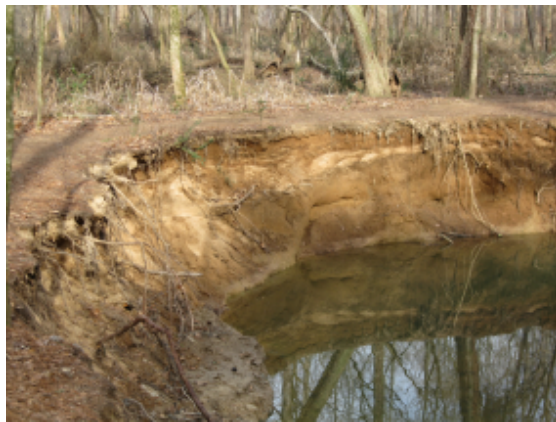
Severe erosion was often observed along the streambank of an outside bend

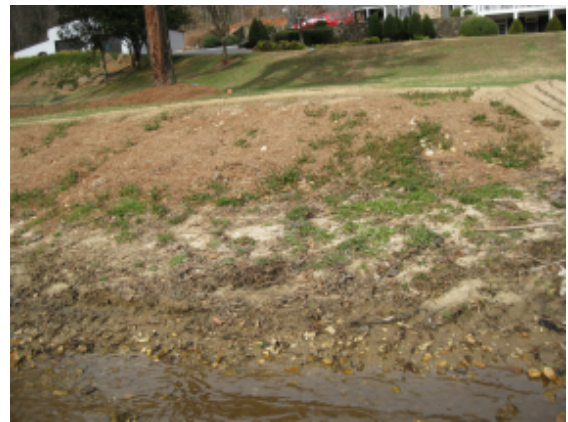
Buffer encroachment was common in residential areas with grassed lawns directly up to the streambank

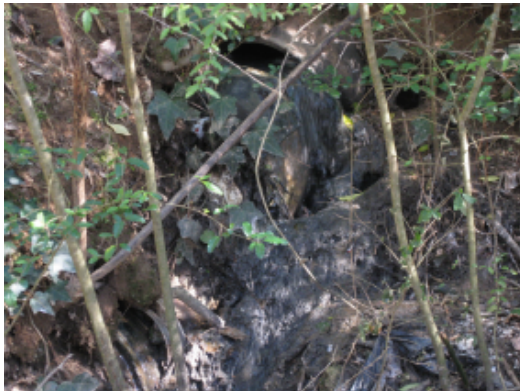
Broken sewer line on tributary of Long Island Creek

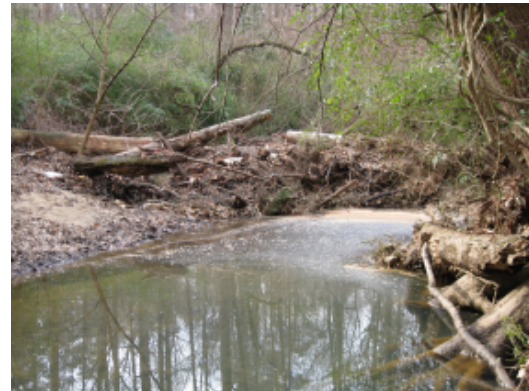
Example of a typical debris jam on Long Island Creek

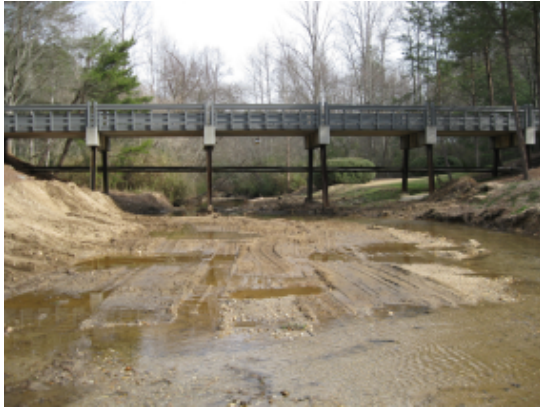
Evidence of vehicles driving through stream

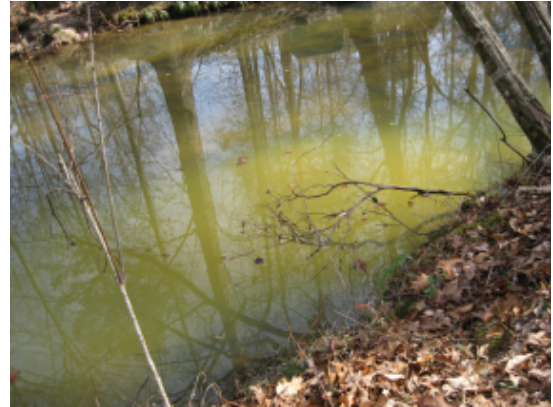
Algae growth observed in the stream

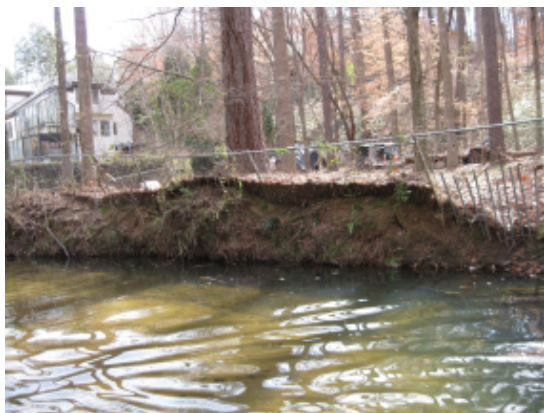
A potential restoration project observed along Long Island Creek

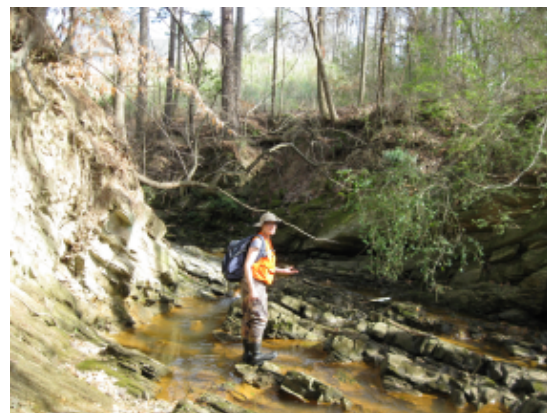
Another potential restoration project observed along Long Island Creek

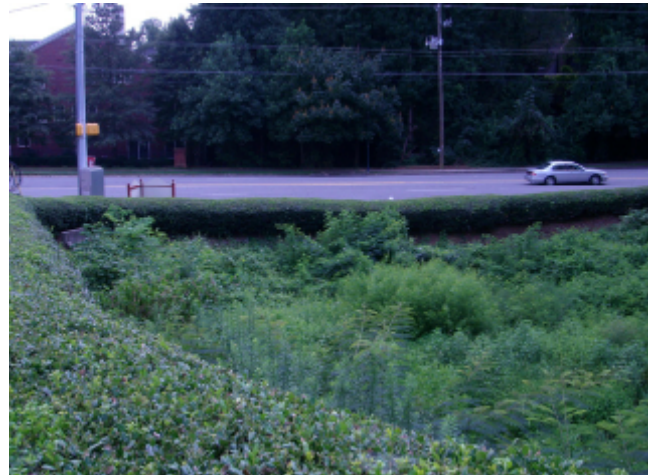
BMP Project 17 00890011061-BMP-1

Project 17 00890011061-BMP-1 is an example of a project that has a benefit/cost score above 5. It includes retrofitting an existing dry pond into a micropool extended detention pond. The existing BMP is located on a Commercial area near Sandy Springs Circle. In a micropool extended detention pond, only a small volume of water would be maintained at the outlet from the pond. The outlet structure would be sized to detain the water quality volume for 24 hours. Temporary storage could also be provided for channel protection and for larger storm events. This proposed retrofit would achieve both water quality and channel protection benefits by converting existing pond to a micropool extended detention pond and redesigning the control structure. There may be site constraints with steep slopes and private land ownership.

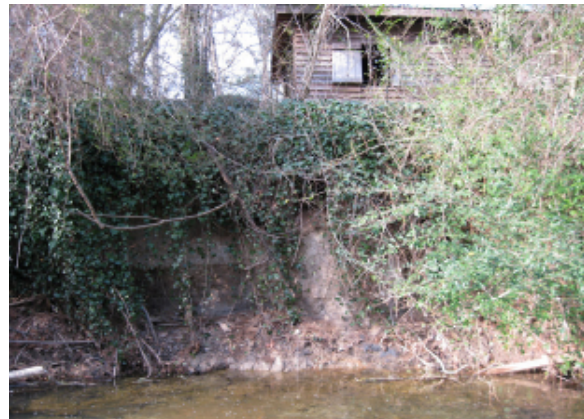
Stream Restoration Project 17 0164 LL068-Stream-1

Project 17 0164 LL068-STREAM-1 is a level 4 stream restoration project proposed along the right bank. The right bank has collapsed and has encroached onto private property. A residence is very near the edge of right bank where the bank angle is greater than 90 degrees. Level 4 restoration involves stabilizing the stream in place by grading the banks to a lesser slope and installing in-stream structures to hold the present streambed elevation and slope. Hard structures, such as riprap, and/or bioengineering techniques, such as livestaking, can be used to increase bank stability. An improved and wider riparian corridor could also be planted.

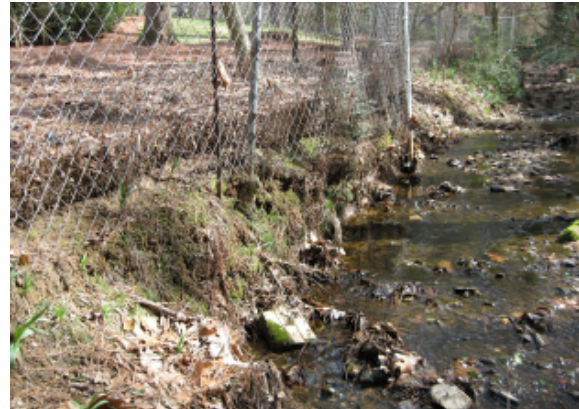
Stream Restoration Project 17 0135 LL059-Stream-1

Project 17 0135 LL059-STREAM-1 is a level 2 stream restoration proposed along approximately 350 feet of stream where the stream is actively widening. The right bank is eroding under a fence along private property. The stream can be moved toward the left bank and away from the encroached private parcel. A Level 2 approach is recommended. This approach involves restoring the stream and floodplain within the existing channel at the present elevation or a new channel adjacent to the old channel but at the same elevation. The new channel will be based on a stable dimension, pattern, and profile. The City may wish to establish a vegetated buffer along the stream.
