FULTON COUNTY  
DEPARTMENT OF  
PUBLIC WORKS

# Water Resources Management Program

## Volume 7 - Sandy Springs Study Area

June 2001

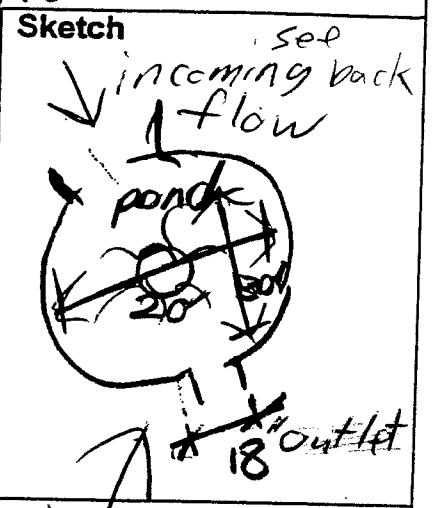
Comments: FOUNTAIN See Back CLARIFY

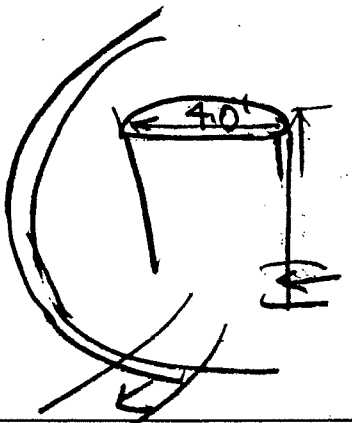
Comments: INCOMING IS COMING FROM THE CREEK
